# FORENSIC ENGINEERING FOR STRUCTURAL FAILURES

A PIARC TECHNICAL REPORT

TECHNICAL COMMITTEE 4.2 *BRIDGES*

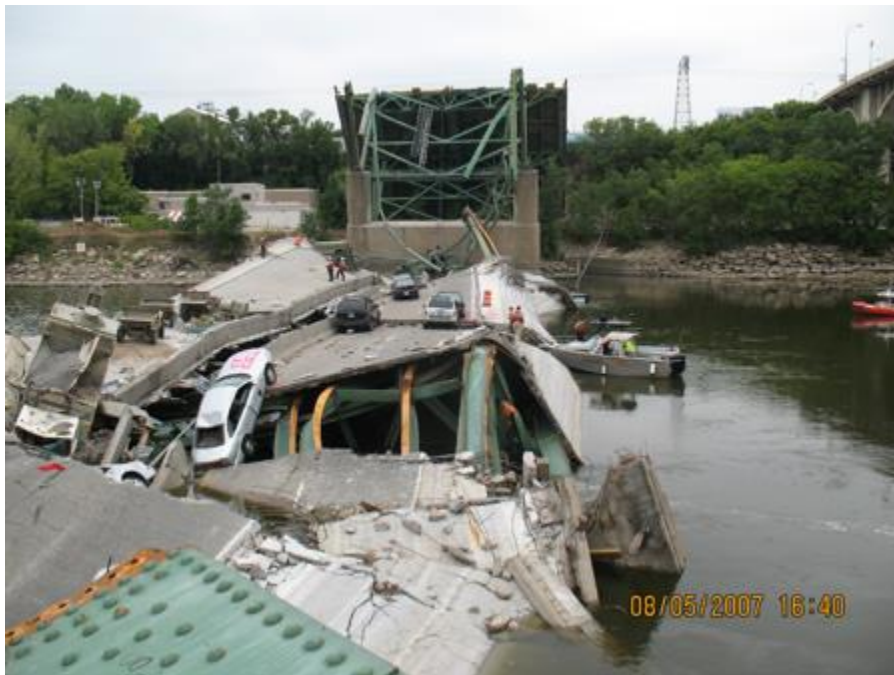
*Figure 1: Wreckage of the I-35W Saint Anthony Falls Bridge which collapsed into the Mississippi River in Minneapolis, Minnesota, USA, on August 1, 2007.*

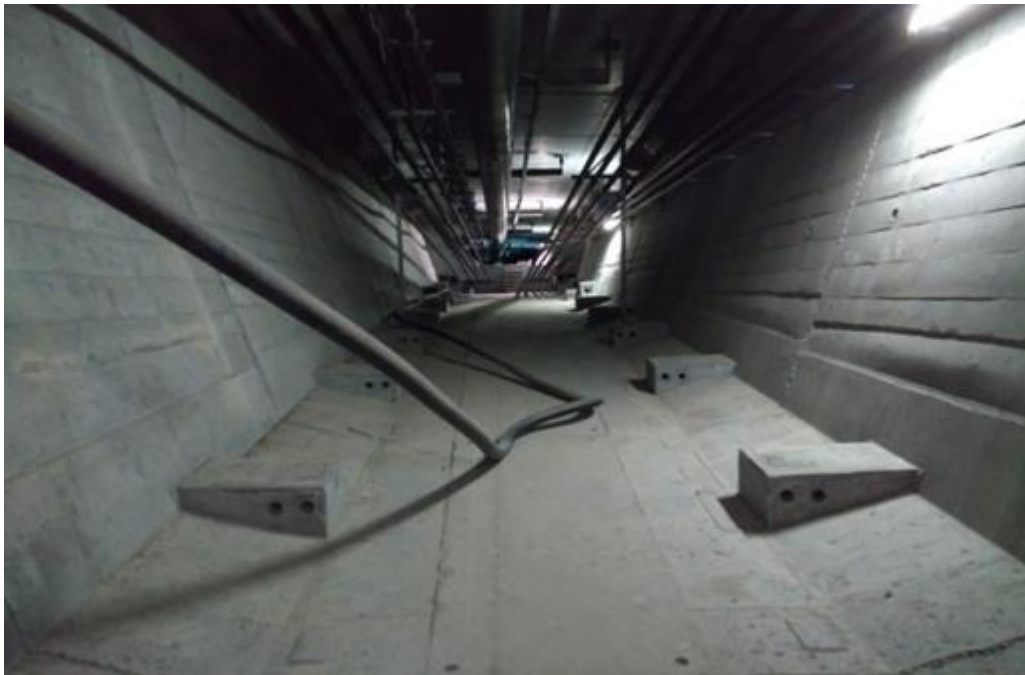
*Figure 2: Photo of a failed post-tensioning tendon inside the Ré Island Bridge outside La Rochelle, France, on September 13, 2018.*

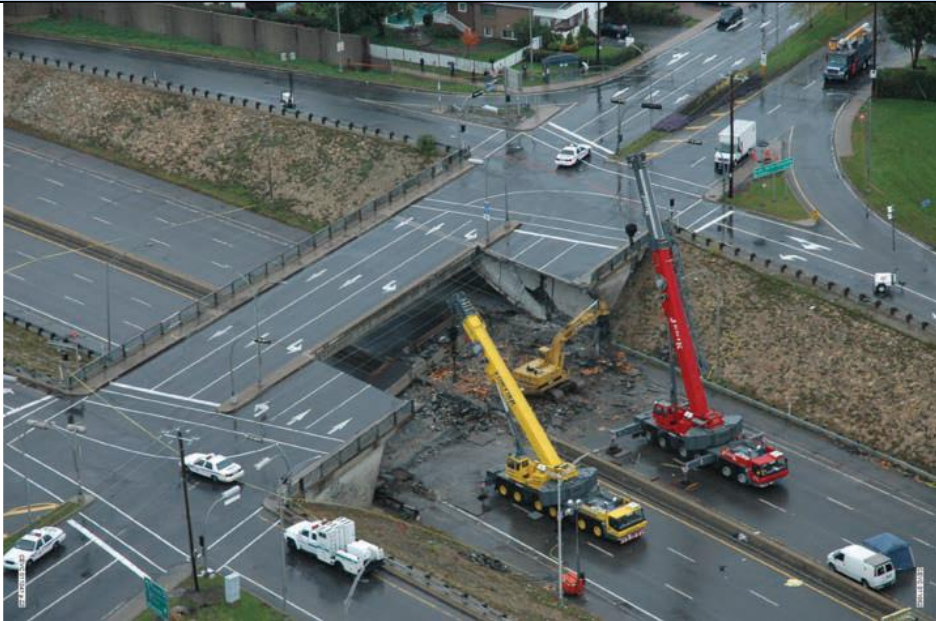
General view of the collapsed bridge

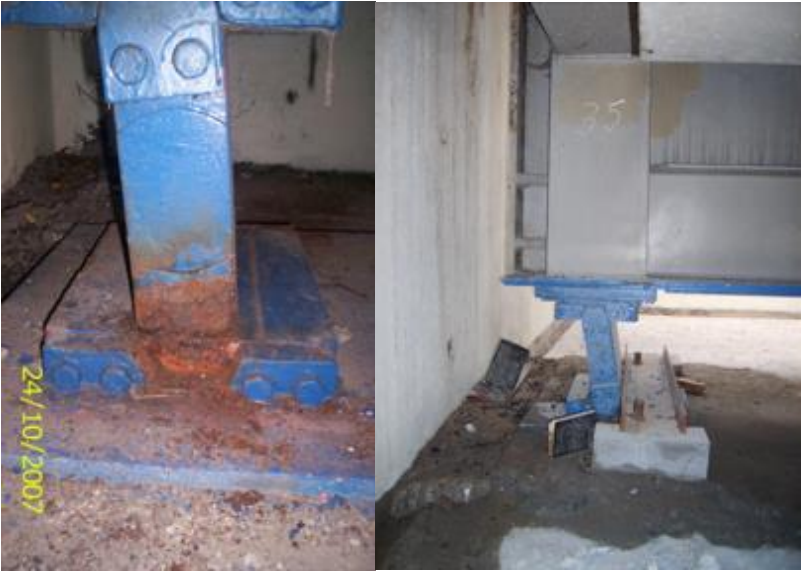
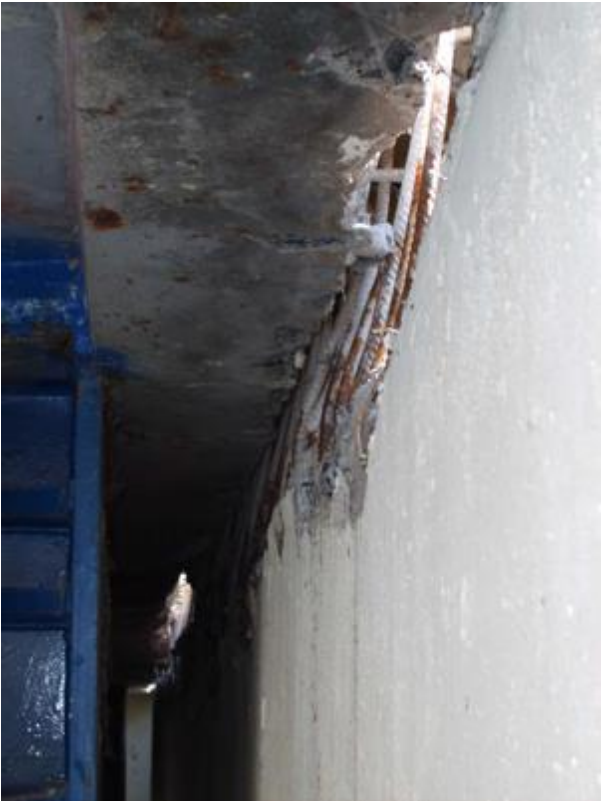
| Case : Failure of Abutment Backwall | |
|---|---|
| Picture of the failure | <div></div> <p>Status of the compression of the deck on the backwall after hydrojetting of the backwall :</p> <div></div> |

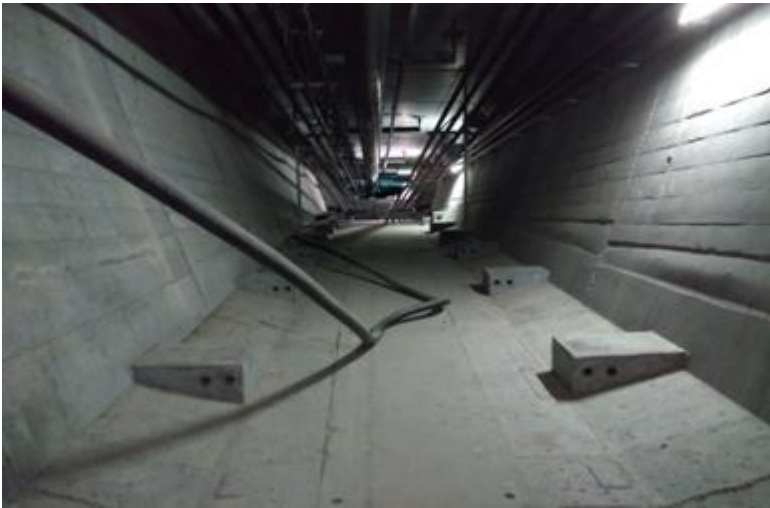
| Case : Ré Island Bridge | |
|---|---|
| Picture of the failure | <p style="text-align: center;"><b>Photo of the broken tendon</b></p> |

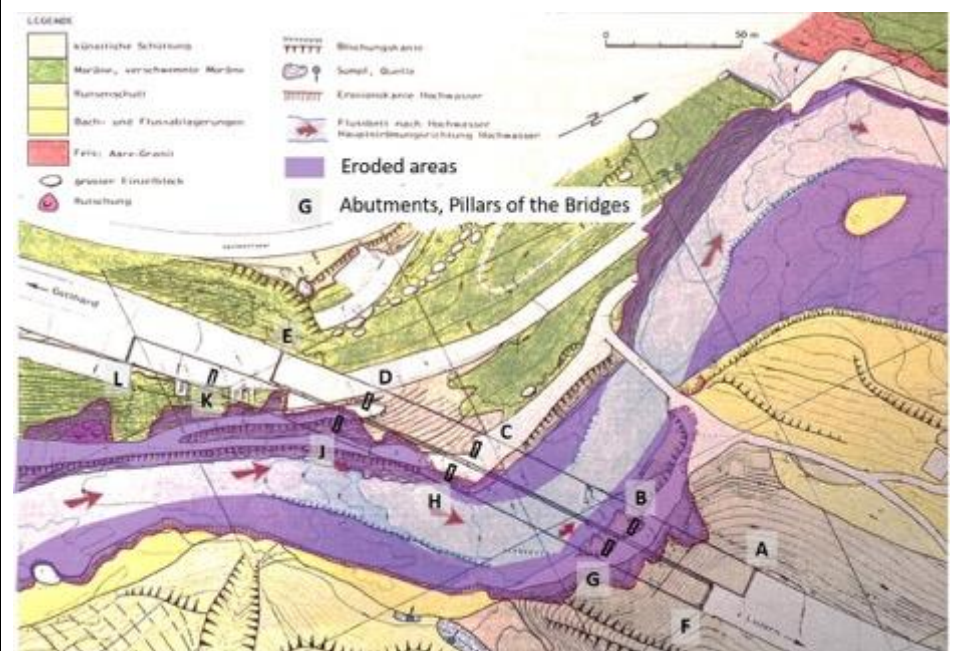
Fig 3: Eroded areas (violet) and foundation of the Wassen Bridge

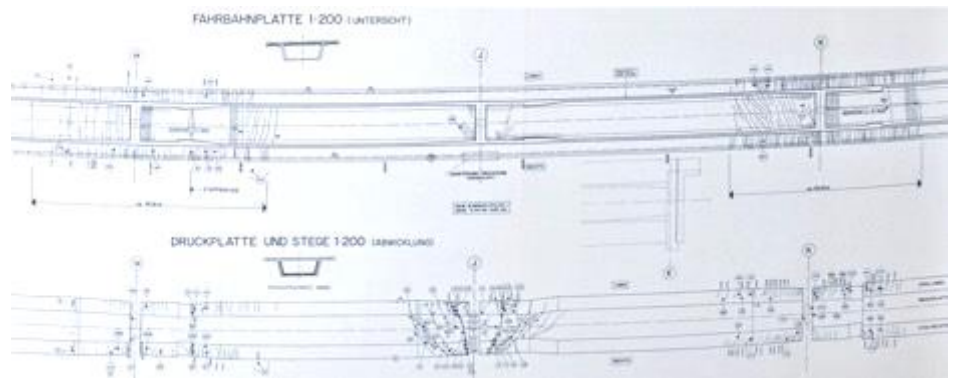
*Picture 6: Supervision of the deck (atop) and folded view at webs and under plate of box girder with marked cracks. In the center Pillar J.*

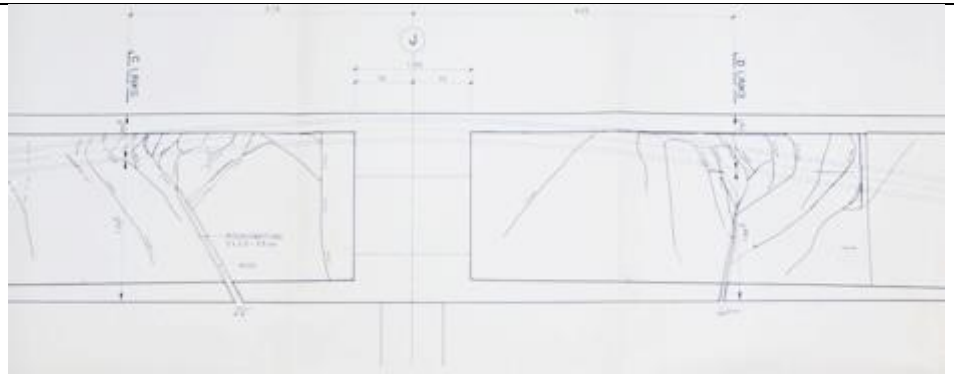
Picture 7: Main cracks in the web in axis J, largest opening 70 mm

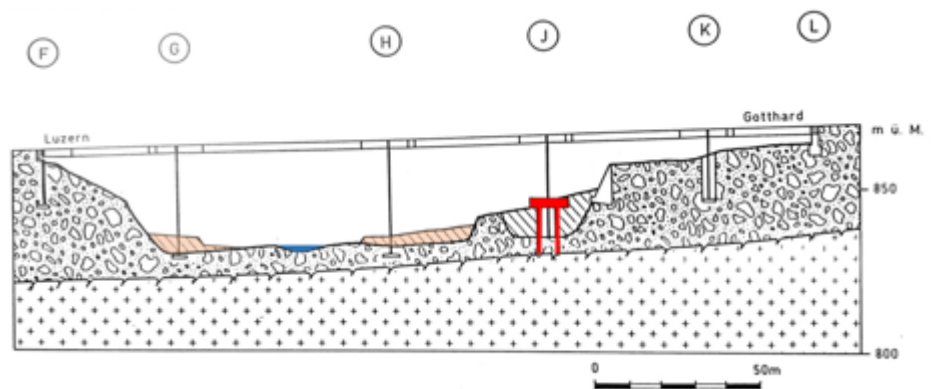
Fig. 4 longitudinal section; base rock, atop gravel, in light brown filled material, in red new foundation of Pillar J. The Reuss is indicated in blue.
