# TECHNIQUES AND INNOVATIONS IN EARTHWORKS

A PIARC COLLECTION OF CASE STUDIES

TECHNICAL COMMITTEE 4.3 *EARTHWORKS*

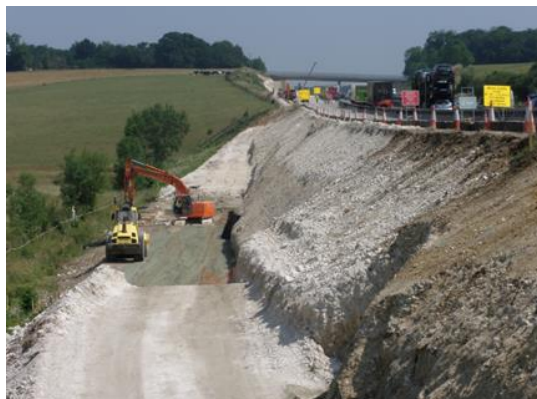
Figure 1: Embankment construction using glass sand

A majority of the glass sand was used to widen an embankment 8 metres in height. It performed well on compaction, although local ponding of water caused some temporary pumping and dilatancy until the water had drained through the compacted fill.

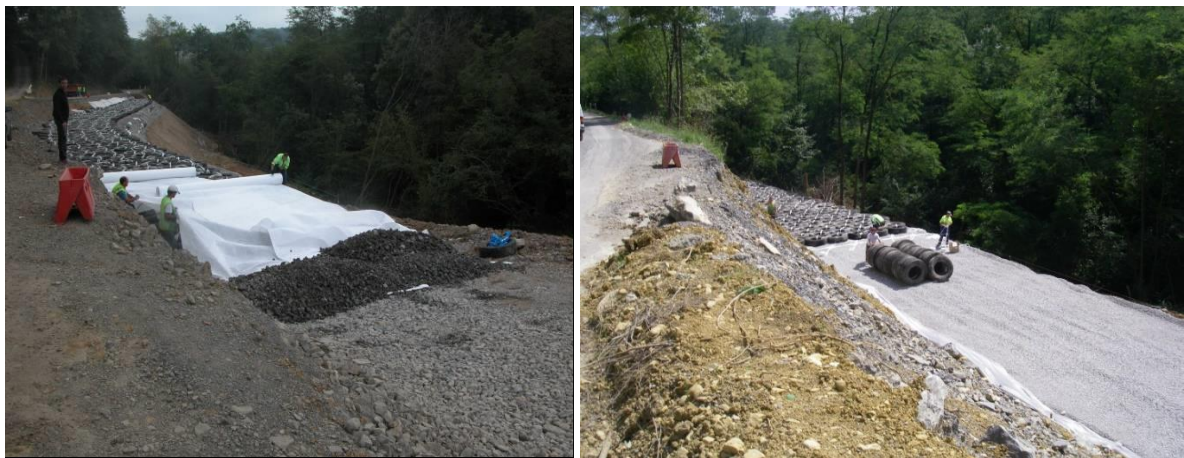
*Figure 2 : Assembly line for Pneusol process – placement of tires and geosynthetic sheets and stockpile of gravel*

For this technique, only gravel, geotextiles, and tires are needed. The work does not require skilled labor, and only light drum rollers are necessary for compacting the material. Once the damaged soil is removed, tires are placed and strongly bonded one-to-another. Flexible geosynthetic sheets are laid between each row of tires and Figure 2). Prior to laying these sheets, each tire is then partially filled with gravel (Figure 3).

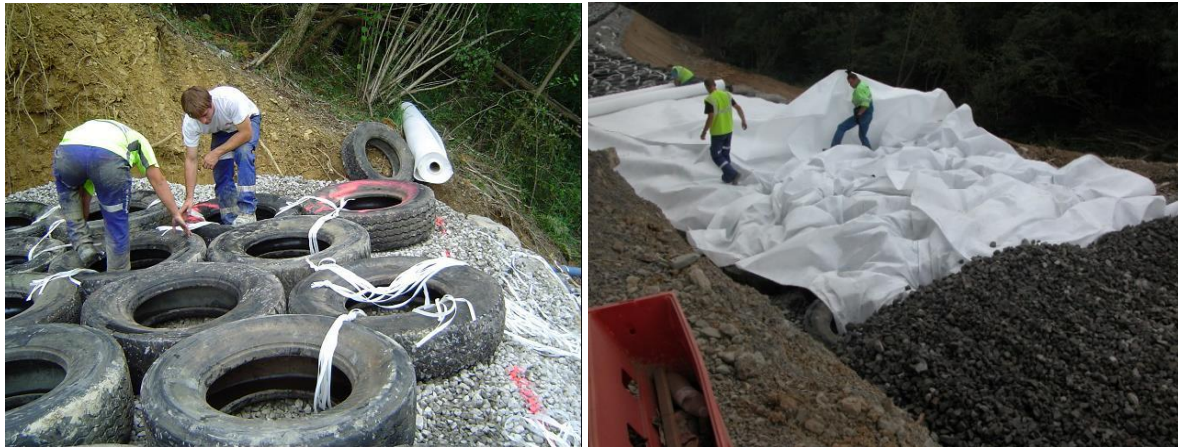
*Figure 3 : tire bonding operation and then fitting the geotextile into the tire hubs*

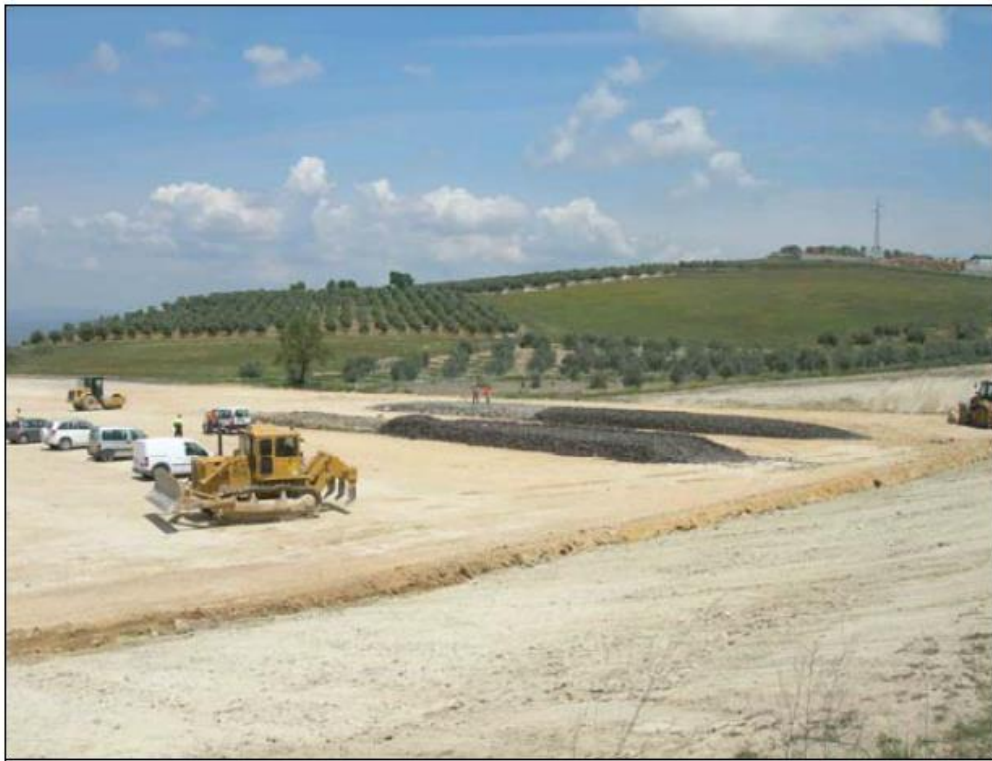
Fig. 1. Construction of experimental embankments made of shredded end-of-life tires (SEOLTs)

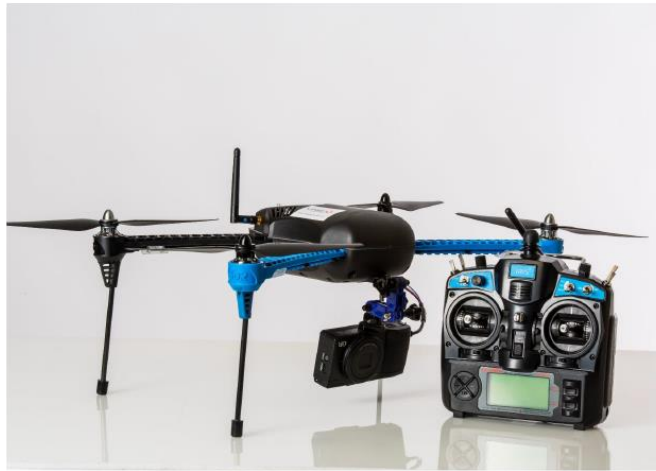
*Figure 5: example of drone and on-board camera*

Data is acquired with a simple camera supported by a drone for small areas (Figure 5) or Lidar supported by a helicopter for the largest. Thanks to those technologies, we are able to survey large areas in few hours with high resolution and accuracy as opposed to days or weeks using traditional field methods.

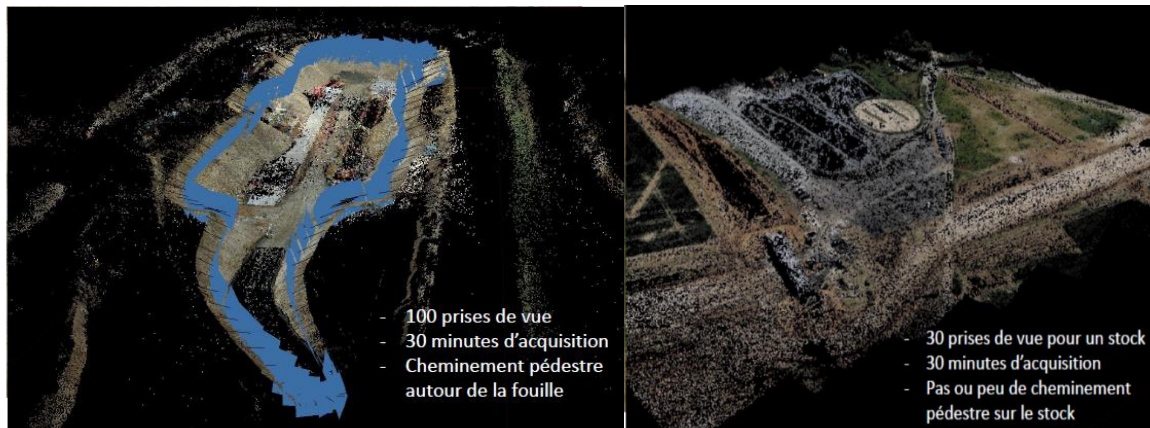
Figure 6: example of the result of a lidar acquisition

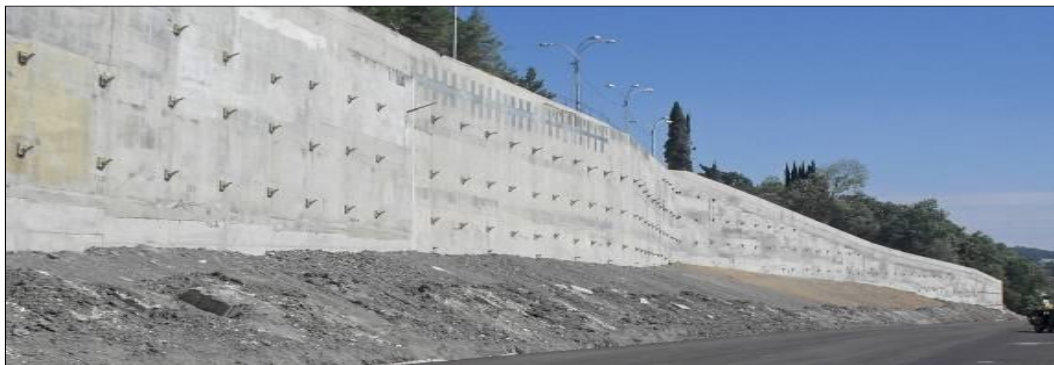
Figure 1. Pile anchor landslide protection structure at the interchange in the area of the city of Sochi

During construction, the large-scale hazard level of a microblock displacement activation hazard remained at the points of a coincidence of the surface inclines and the bedrock stratification. To protect against the effects of hazardous geological processes, the construction of a piled anchor landslide protection structure was envisaged (Figure 1).

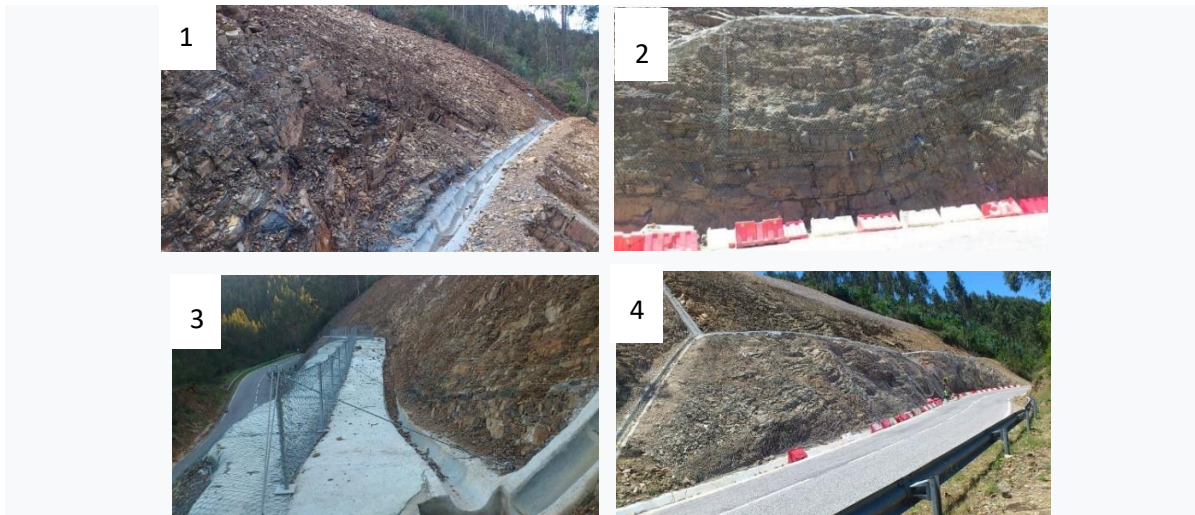
Figure 3 – Construction phase photos: 1) Earthmoving - Removal of unstable material and profiling of the cutting slope, 2) Application of metal mesh, 3) intermediate shoulder, 4) Final view.

1. Deforestation of the cutting slope;
2. Earthmoving - Removal of unstable material and profiling of the cutting slope creation of intermediate shoulder;
3. Internal drainage - geodrains diameter of 50 mm, in PVC pipe crepined and wrapped in geotextile, 5% inclination to the outside. And implemented a superficial drainage system;
4. Application of metal mesh - triple torsion wire mesh.

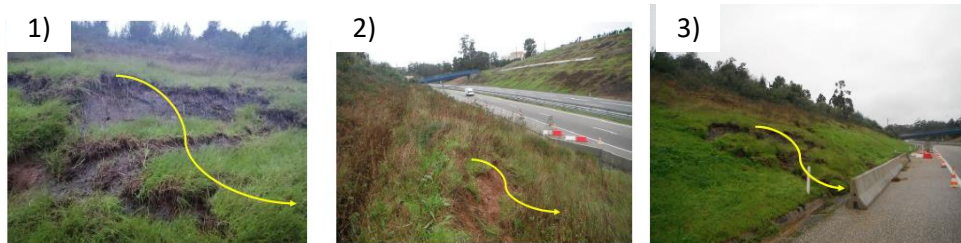
Figure 1 – Damage: Photos: 1, 2 and 3)

On the 19th of December 2019, in a cutting slope on the A17 at PK 100, a very large mass of clay materials liquefied reaching the edge of the highway as a result of the partial rupture of the slope. Concrete barriers were immediately installed to protect the roadway and the roadway users, but the mass volume was significant and cracks were registered in the slope, a phenomenon that increased the percolation of water into the mass and further progressed the rupture.

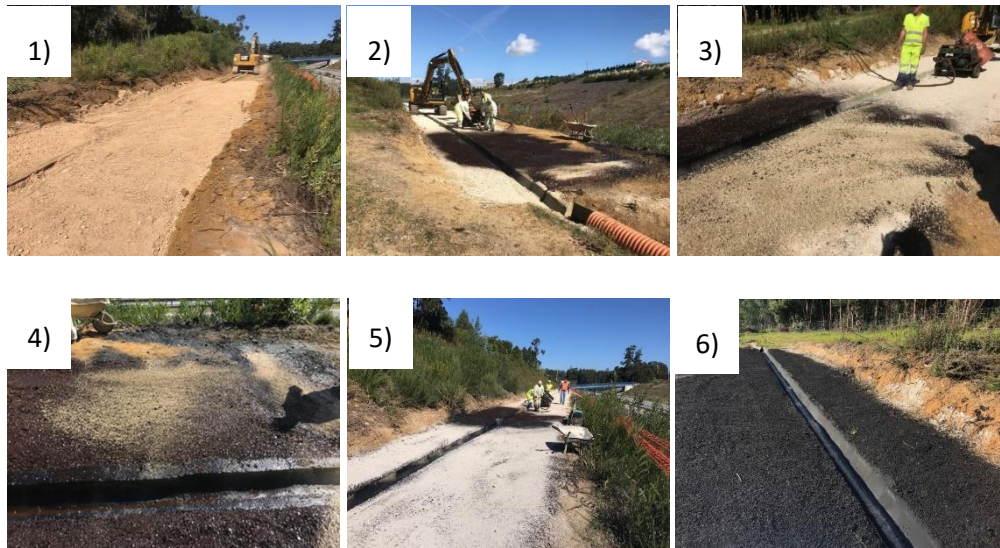
*Figure 2 – Construction Phase: Photos: 1) Removal of all vegetation and removal of the landslide materials from the bottom of the excavation slope; 2) The installation of rockfill, 3) Stripping the entire length and width of the bank, with a thickness of 10 cm and 4 and 5) Waterproofing the excavation slope stool by applying a 10 cm thick granular rock aggregate + 1.5 cm thick double bituminous coating + 6 / 10 mm gravel 6) Final view after the intervention.*

The final surface was covered with 6 / 10 mm gravel, which has the function of protecting against Surface erosion, in an amount that covers the entire watered surface perfectly. The characteristics of the gravel complied with the Specifications for Roads of Portugal 2009.

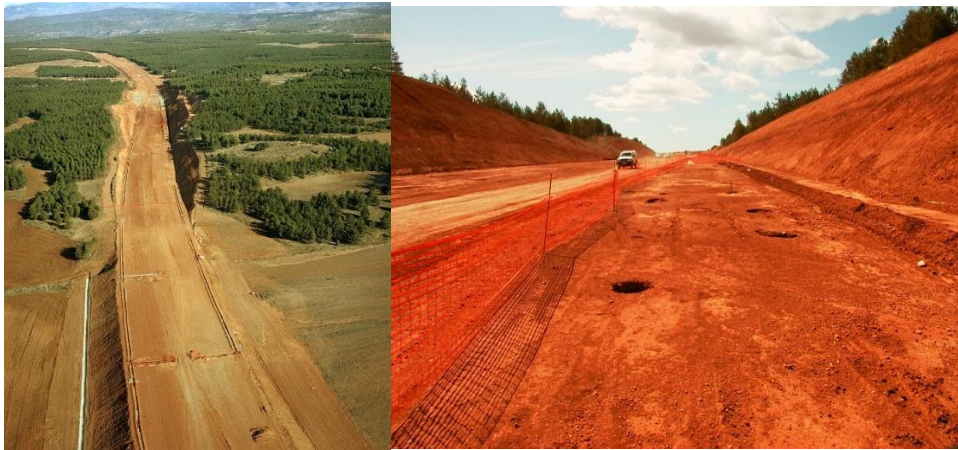
*Fig.1 (left) Aerial view of the cuttings affected by the phenomenon  
Fig. 2 (right) Sink holes observed in the bottom of a cutting*

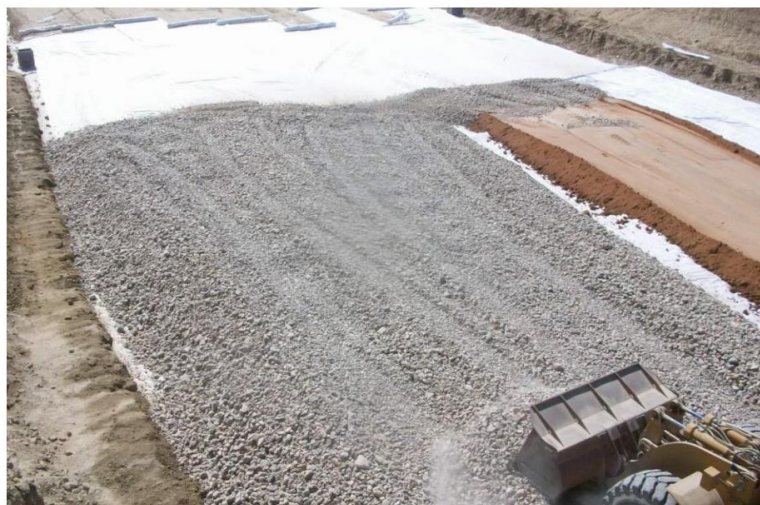
Figure 3. Granular drainage layer, geotextile and backfill layer

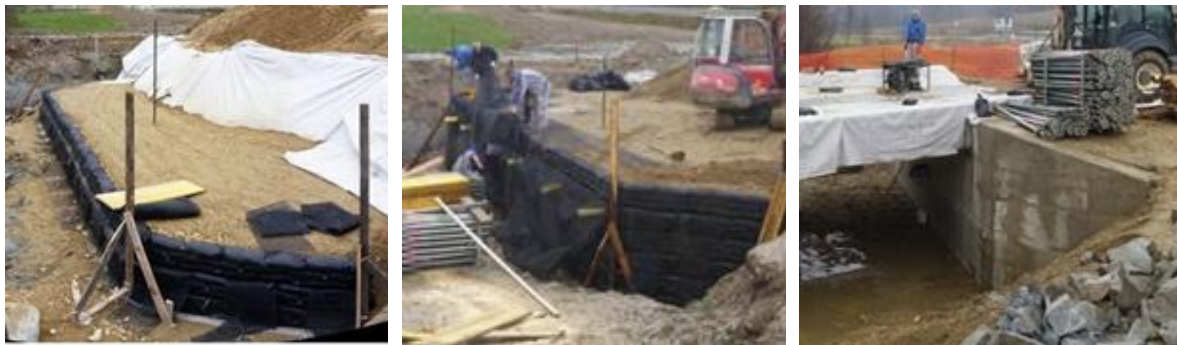
Photos 1,2 and 3 – construction phase

Both GRS bridge abutments were built within a period of less than 10 days due to the simplicity of the construction processes involved. The concrete face and the concrete bridge slab were then built using appropriate formwork and cast-in-place concrete.

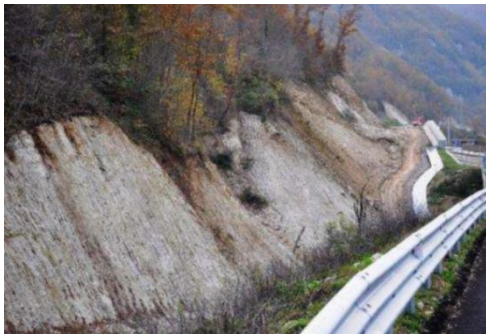
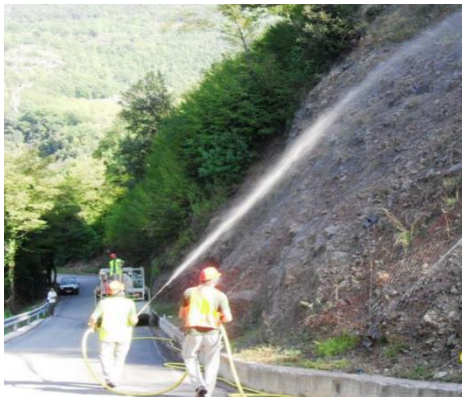
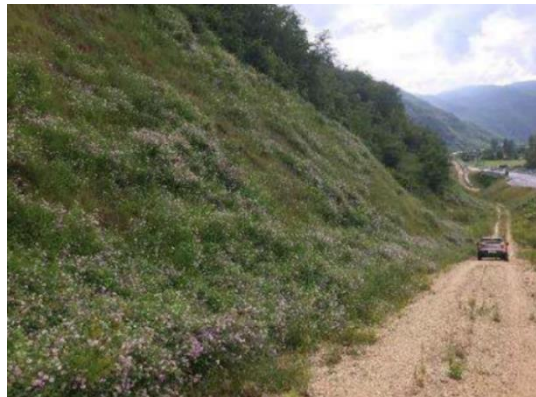
*From top left clockwise: slopes before works, typical geometry of long roots, the slopes as they present after works, hydroseeding.*

Prati Armati<sup>™</sup> is a very environmental-friendly technique. Seeds are put in place by using hydroseeding from the bottom. Special equipment is required to reach the upper parts of high slopes only. Road can be left open to traffic during installation operations.

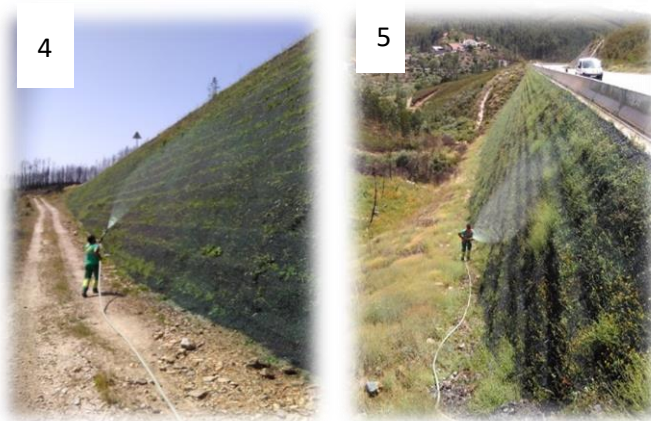
Figure 3 – Construction Phase 2017: Photos: 4) and 5) Hydroseeding works

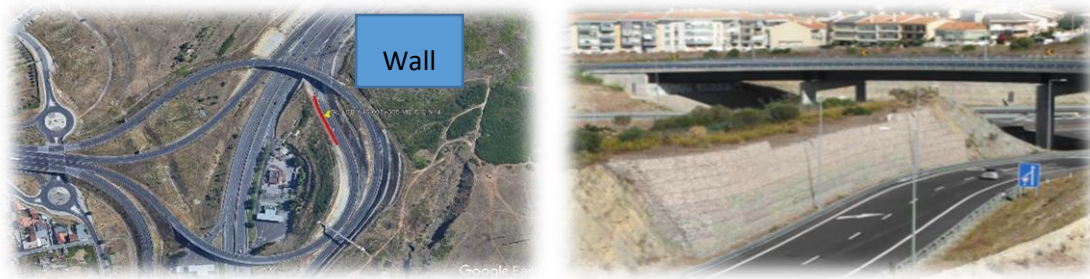
*Figura 1: localization and longitudinal view of the gabion wall*

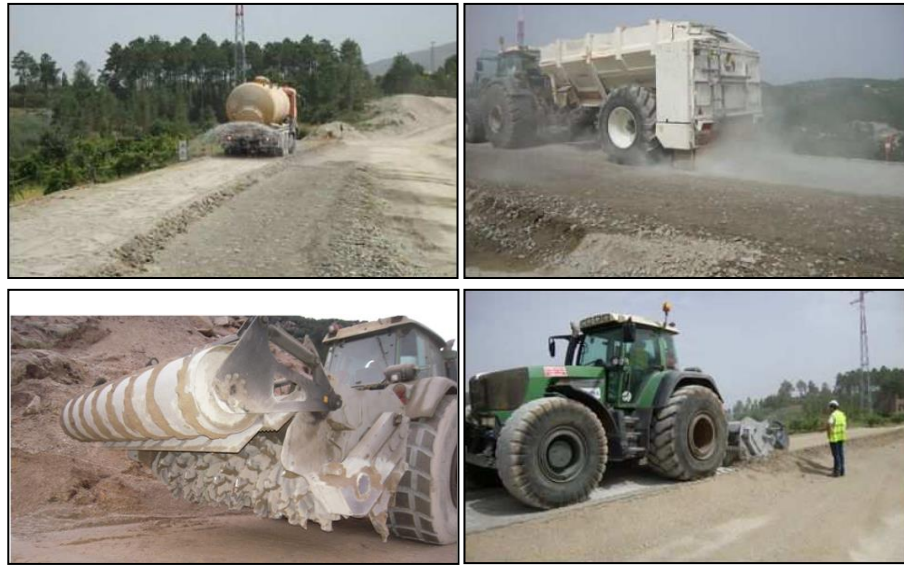
*Construction Phase Photos (Clockwise from top left) – a) Placement of water, b) Addition of cement, c) Operation of mixer, d) Close up of mixer*

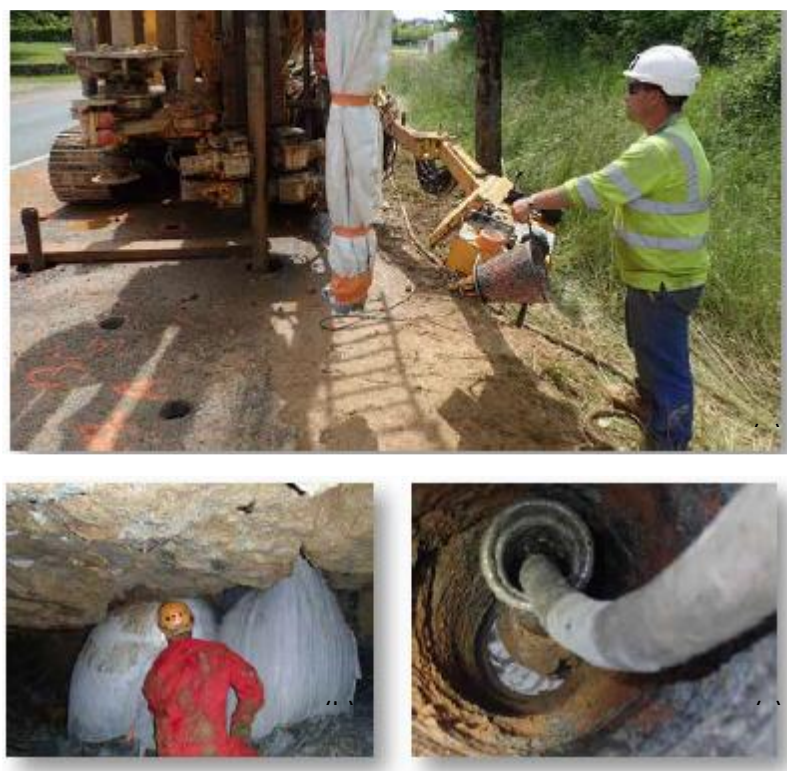
Figure 17 : the CAVIBAG process, developed by Cerema (Courtesy Cerema)

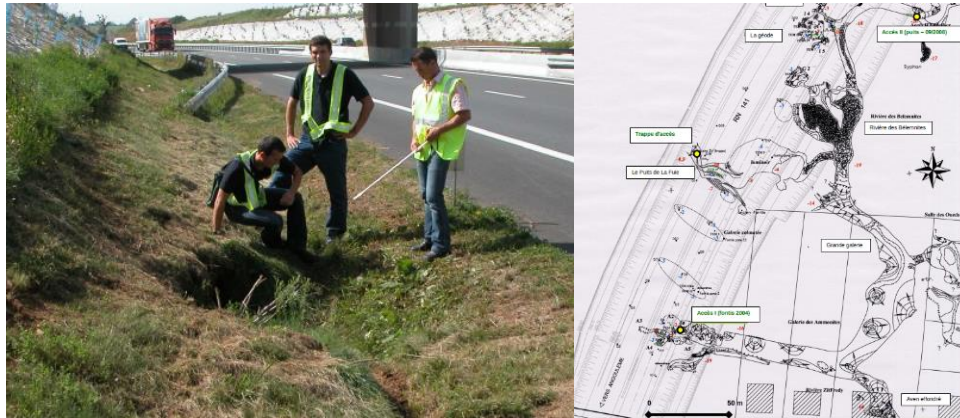
Figure 18 : inspection of LA FUIE cavity, RN.141, France (Courtesy Cerema)

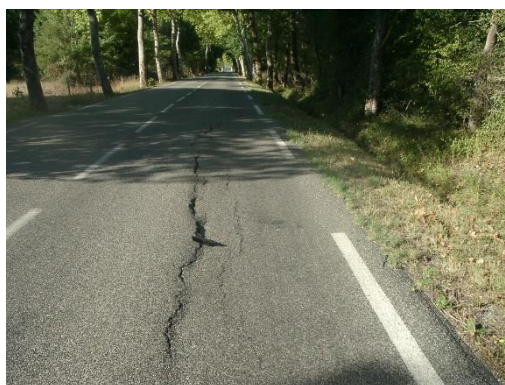
Figure 19: Example of damages in the south of France.

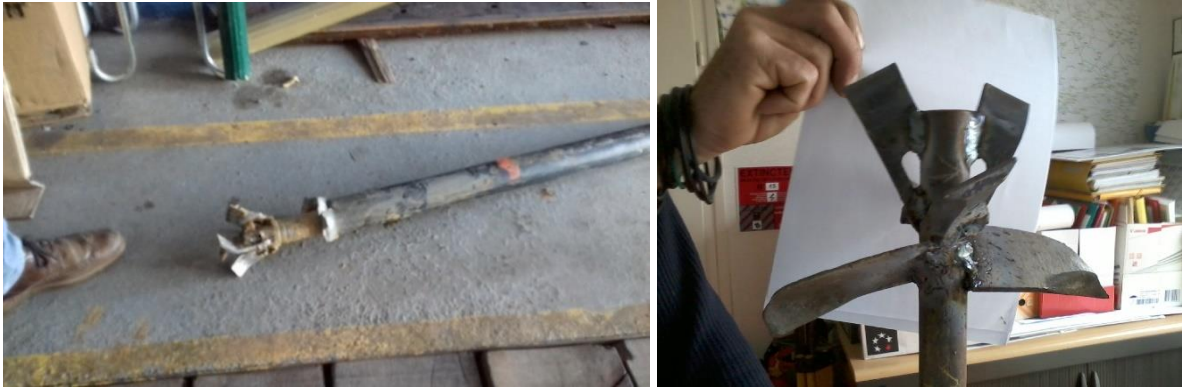
*Figure 20: A specific tool has been adapted to incorporate lime into the soil with a vertical borehole*

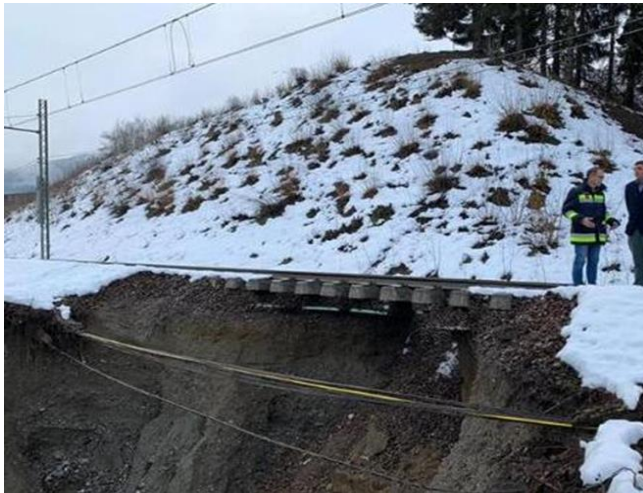
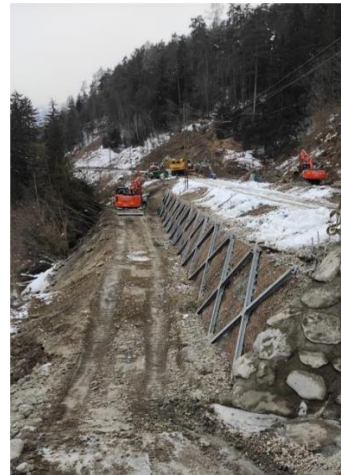
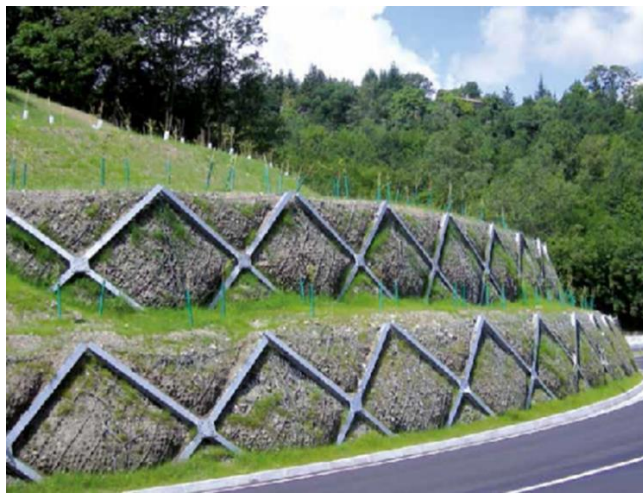
*From top left clockwise: railway embankment damaged, the railway during works, the pyramid-shaped element, a similar work as it is finished.*

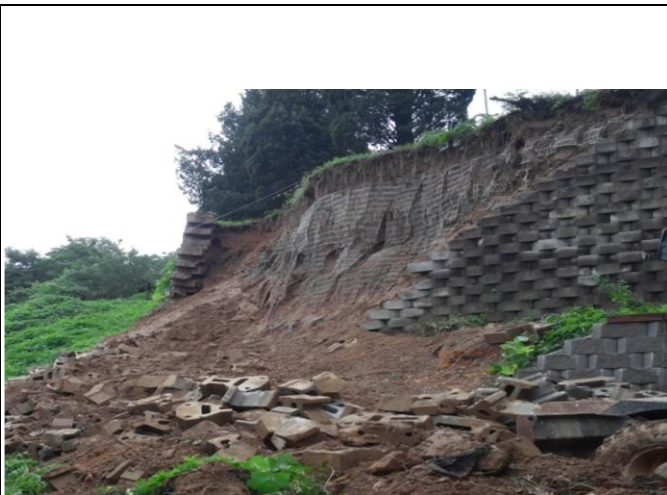
Photo 1. Failure of SRW

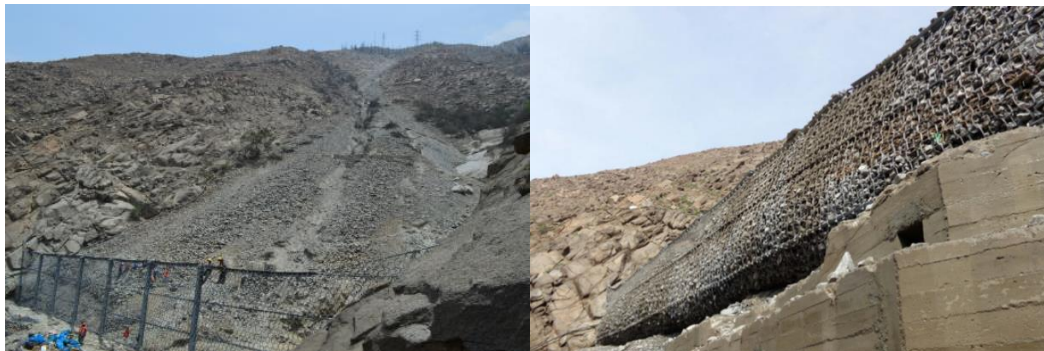
*UX barrier instalation – Carosio Ravine (2016)*

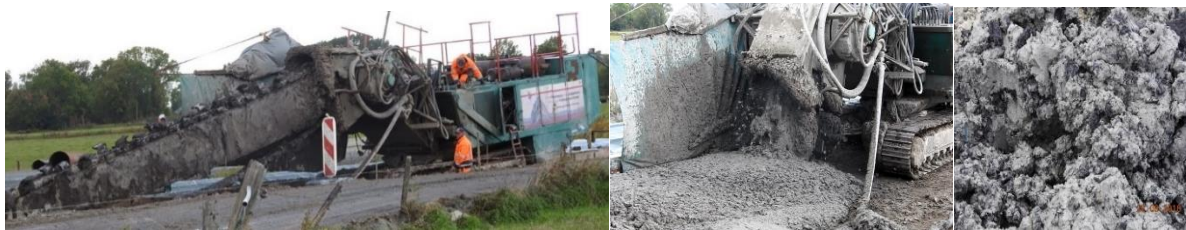
*Pictures: The FMI (cut-mixing-injection) machine - Sidla & Schönberger Germany*
