# INNOVATIVE PAVEMENT MAINTENANCE AND REPAIR STRATEGIES

A PIARC CASE STUDIES COLLECTION

TECHNICAL COMMITTEE 4.1 *PAVEMENTS*

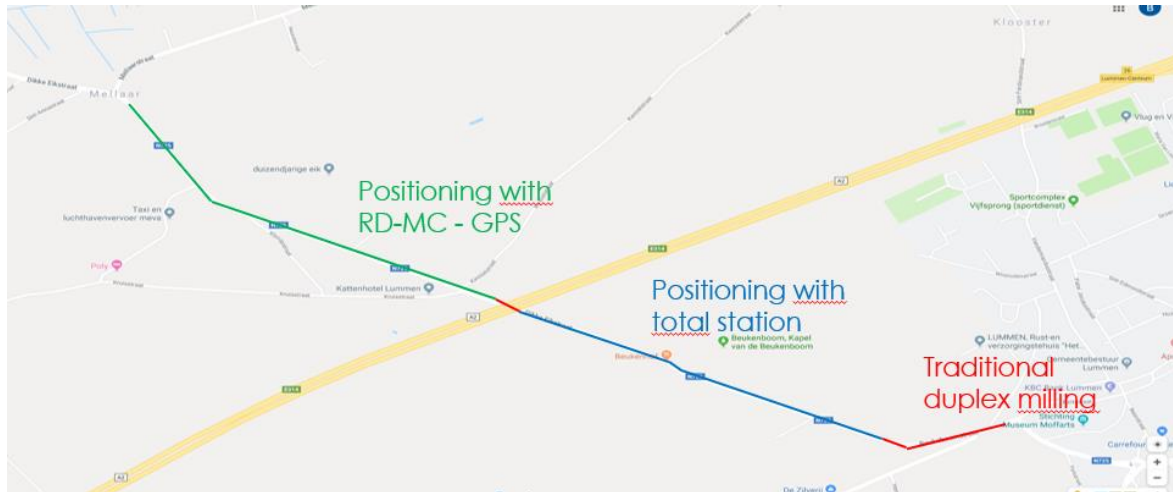
Figure 3: Test site location with indication of the different sections<sup>1i</sup>

On the covered part of the road (blue part on the map in

On the road section located in an open area (green part on the map in

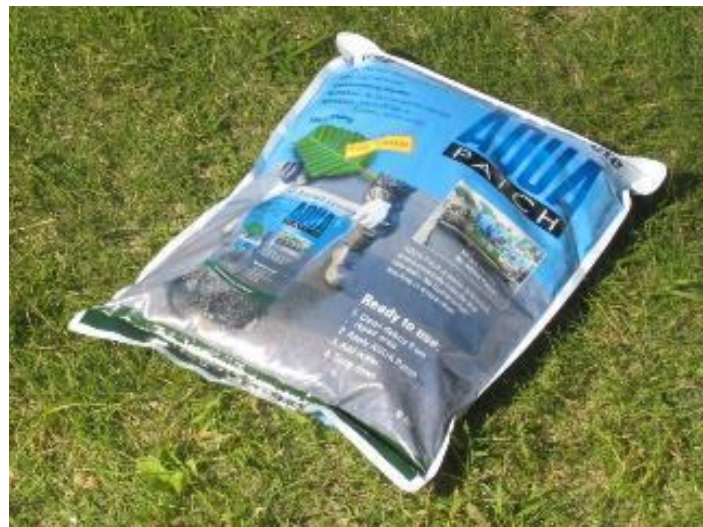
Figure 12: The appearance of AQUA PATCH

“AQUA PATCH” is an entirely new type of cold mix, it is an ideal repair material which cures by adding water and tamping down. It can even be used in the places where potholes are filled with water. It has high durability and quick hardenability compared to with the conventional asphalt patches. Figure 12 shows the appearance of AQUA PATCH.

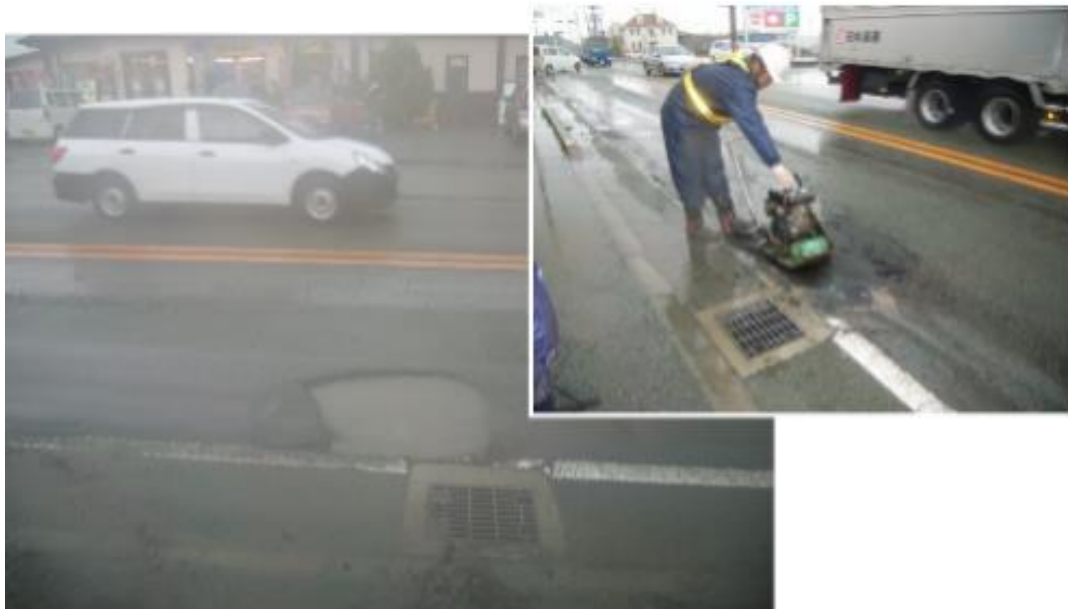
Figure 17: Evaluation test in rain

**Erreur ! Source du renvoi introuvable.** shows the repair status in rainy weather. “AQUA PATCH” can be applied even in rainy conditions or on a pothole filled with water. Both of this water will help to be harden rather than bother it.

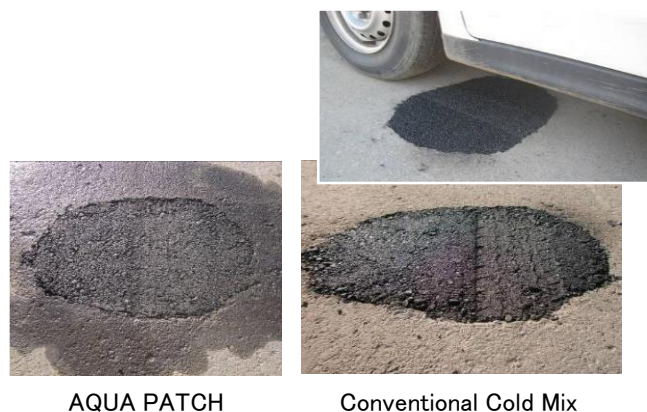
Figure 18: Durability immediately after repair work

To verify the strength development of this new mixture, a car was driven over the road immediately after pothole repair, as shown in Figure 18, and the road surface profile before and after the tires had run over the road were measured, as shown in Figure 18. Photo in the left-hand side is “AQUA PATCH”, and right one is other Conventional Cold Mix. Less tire marks can be seen on “AQUA PATCH” on the left. *Table 1* include the test results. Rutting is less compared to conventional cold asphalt mixtures, indicating that the mixture has superior initial durability.

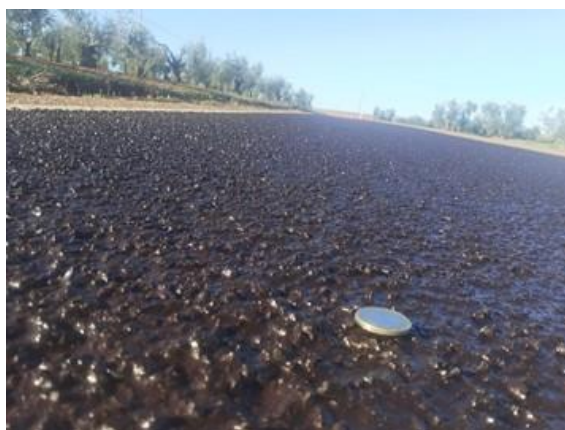
*Figure 20: Aspect of a Microf 8 treatment*

The surface area treated was 29400 m<sup>2</sup>, with an application of 11 kg/m<sup>2</sup>. The work, included the milling of road markings and, was completed in 5 days. The appearance of the treated surface immediately after construction can be seen in Figure 20.

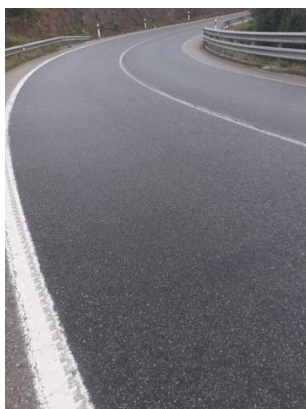
*Figure 21: Current conditions of Microf 8*

Current conditions of the route after more than 4 years in service can be seen in Figure 21.

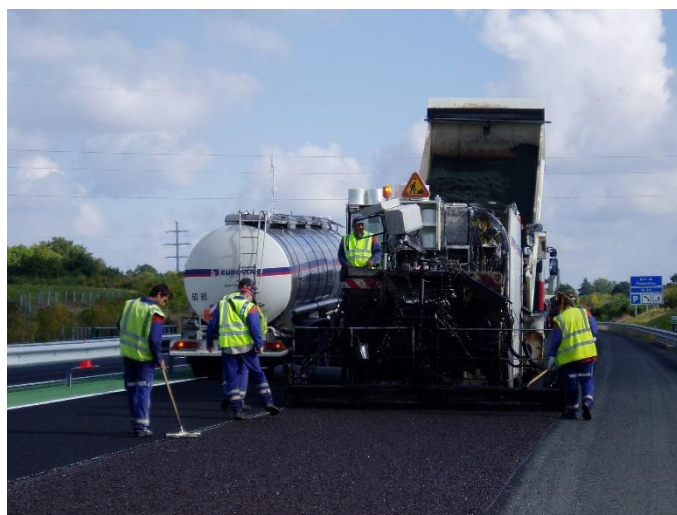
Figure 23: A 87 treatment application

The work was executed in 6 and a half days. The treated surface was 117300 m<sup>2</sup> constructed in two layers (234600 m<sup>2</sup>). The daily output was 36,000 m<sup>2</sup>. Application speeds ranged from 1.5 to 2.5 km/h for a width of 3.8 m.

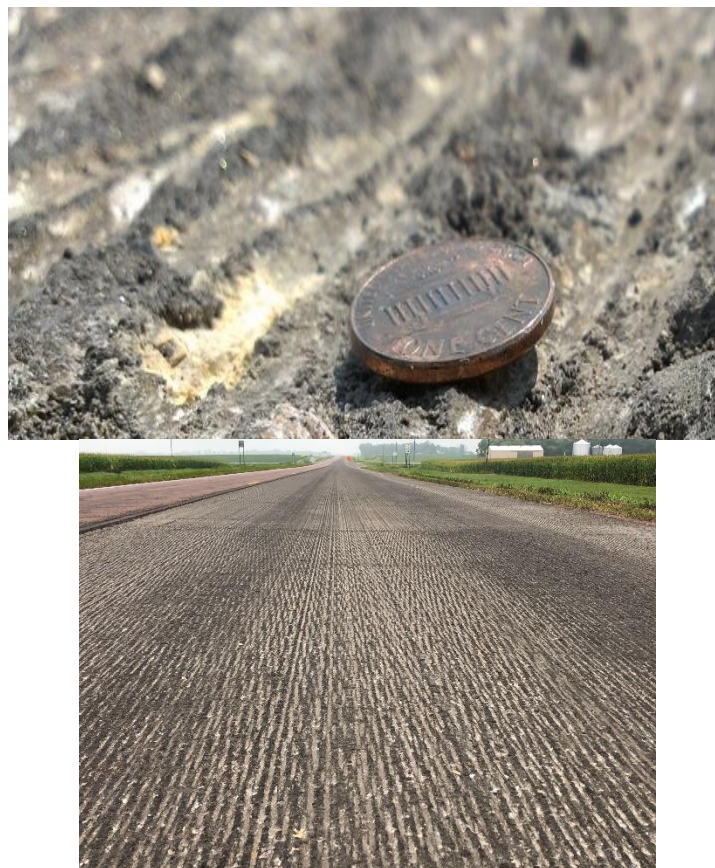
Figure 25: Micro Mill Photos: Finished micro mill texture and Micro Milled Pavement

A similar process to traditional pavement milling which uses a milling drum having about three times as many teeth as a typical milling drum. The additional teeth provide a tighter lacing pattern and smoother surface, providing a better surface than traditional milling for application of thin pavement surface treatments.

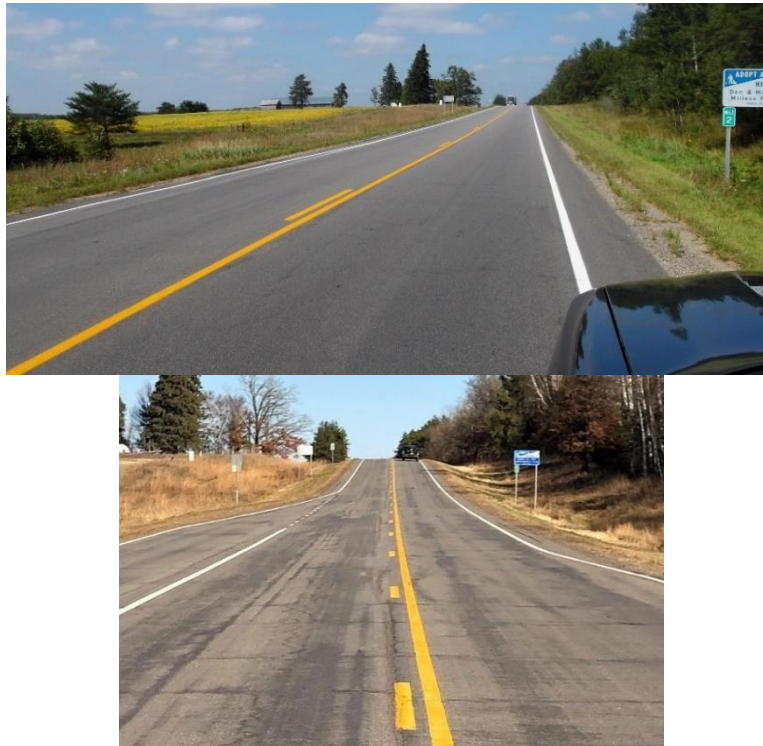
Figure 28: Rural Undivided (TH 64) Photos: After 1 Year (2015) and Year 6 (2020)

In 2014, two projects were micro milled prior to micro surfacing. Performance is documented in the chart below and Table 1. Based on the MRI data trend, these projects will reach their pretreated condition in about year 10.

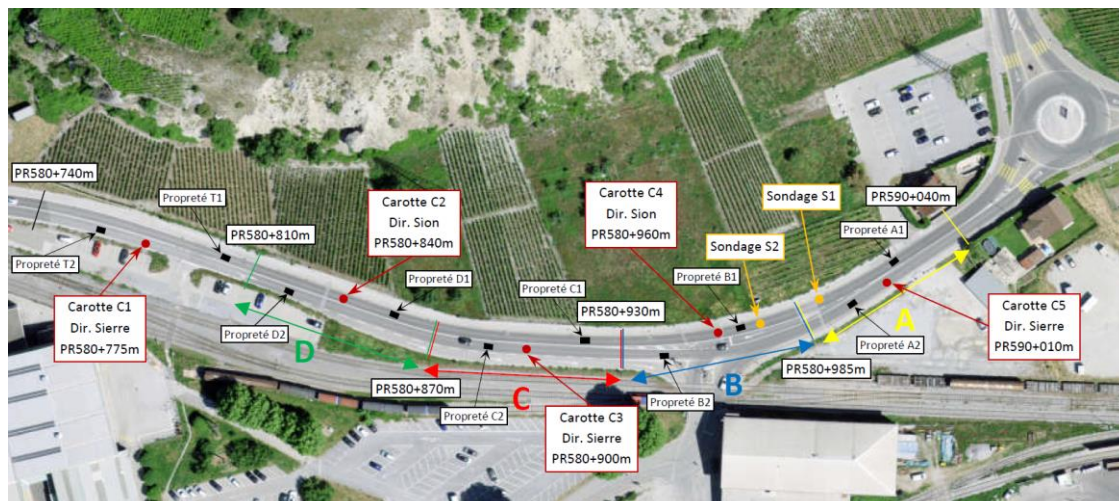
Figure 35: Test section overview

The test section was constructed in October 2022 where 4 different types of grids as well as a reference section without grid was compared. Each section had a surface of approximately 350 m<sup>2</sup> (50 m length). The job site consisted of milling 40 mm asphalt and then installing the reinforcement grids before the laying of a new asphalt top layer. The construction of the test section permitted to make an extensive comparison of different products and laying strategies.

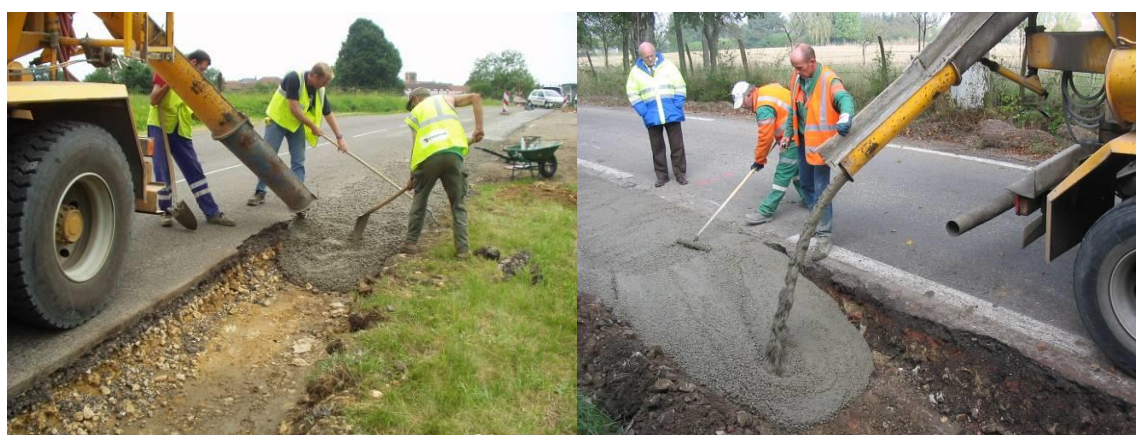
*Figure 47: The material MACES is simply poured from truck mixes (left: RD 952 in 2003; right RD 19C in 2006)*

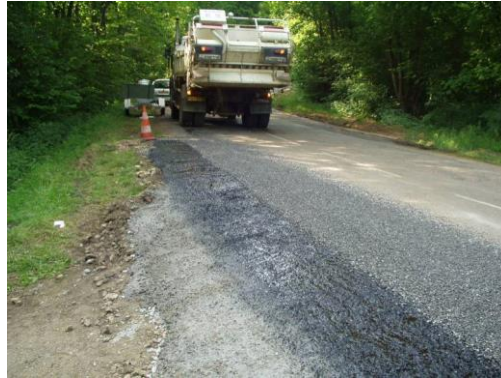
Figure 48: Surface dressing spread on the surface of the edge beam after setting

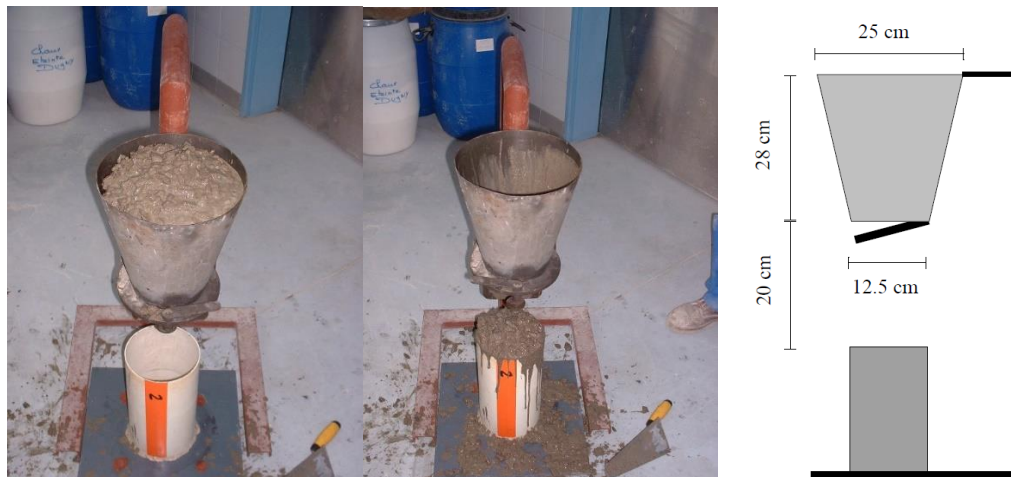
Figure 49: Measurement of the self compactability of the material by filling  $\varnothing 16\text{cm} \times 32\text{ cm}$  cylinders with the Glanville apparatus (from [2] and [3])

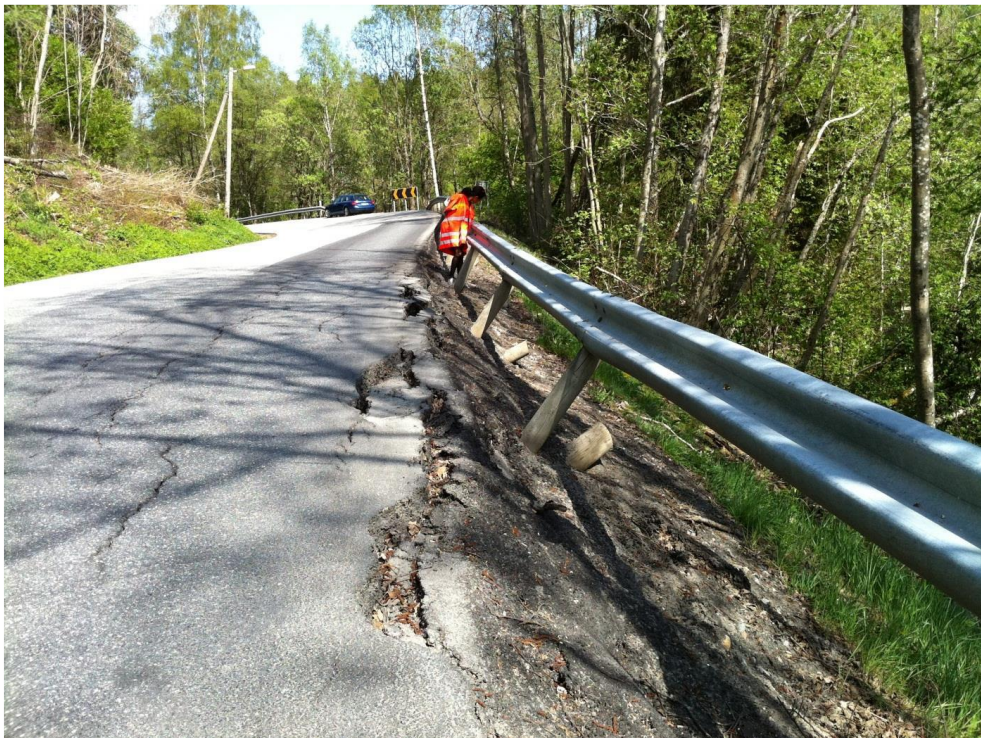
Figure 52: Longitudinal cracking and damage at the edges of the road due to settlements [4]

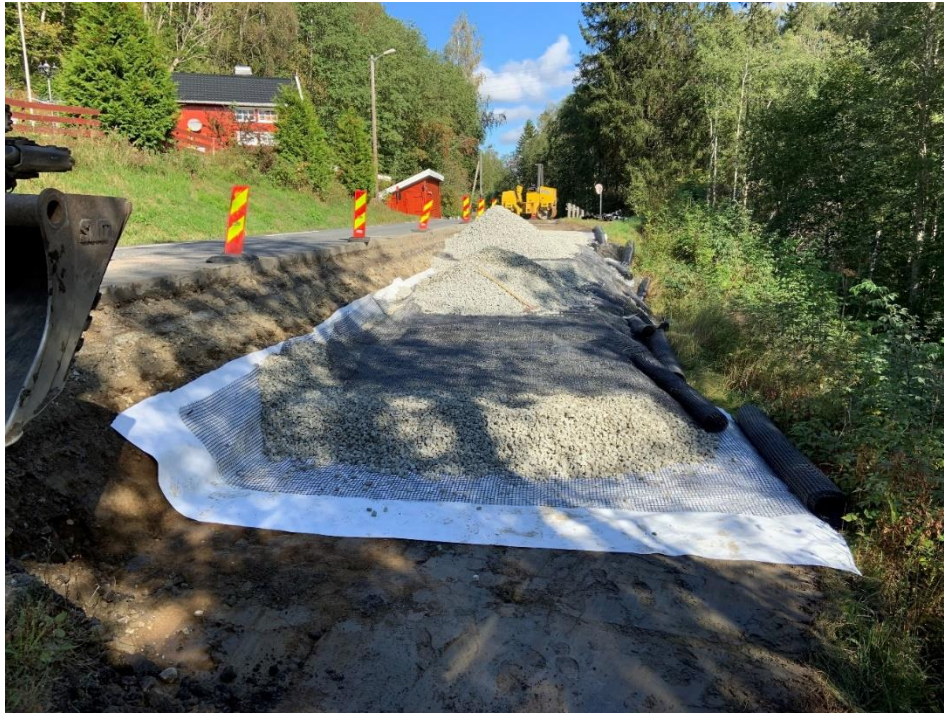
*Figure 54: Nonwoven geotextile, geogrid and 40 cm foamglass is placed [4]*

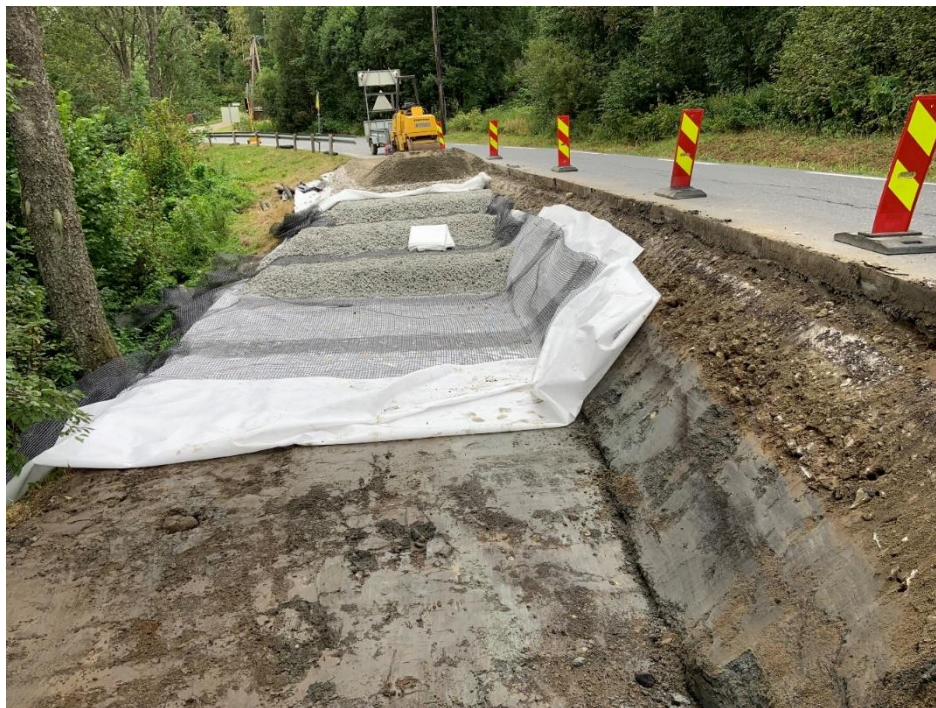
*Figure 55: The next layers of foamglass is placed (Photo: Jan Vaslestad)*

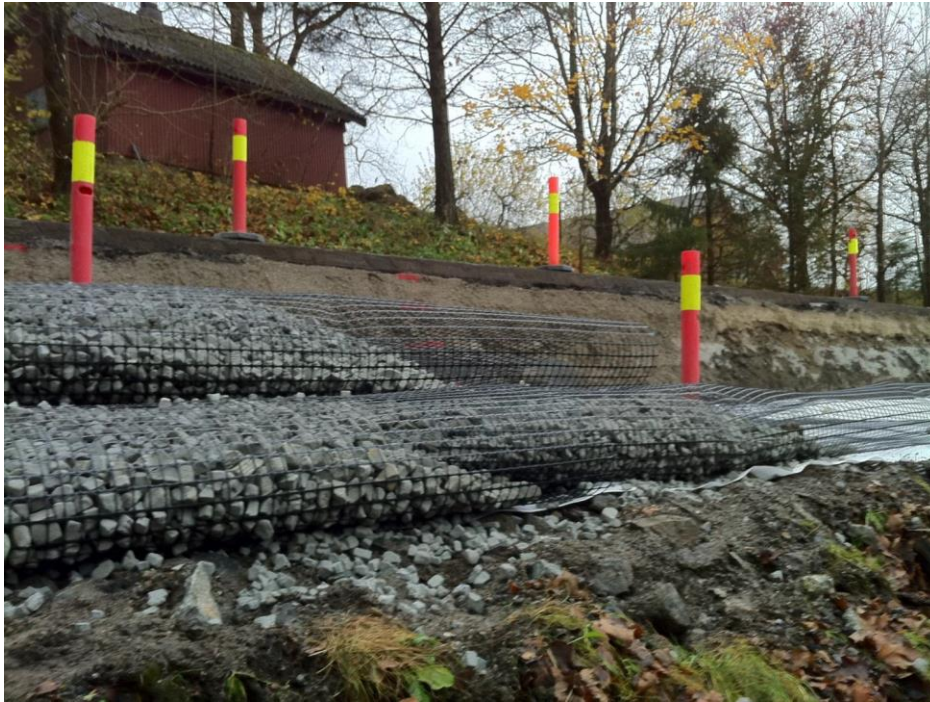
*Figure 56: The geogrid is wrapped around the foamglass [4]*

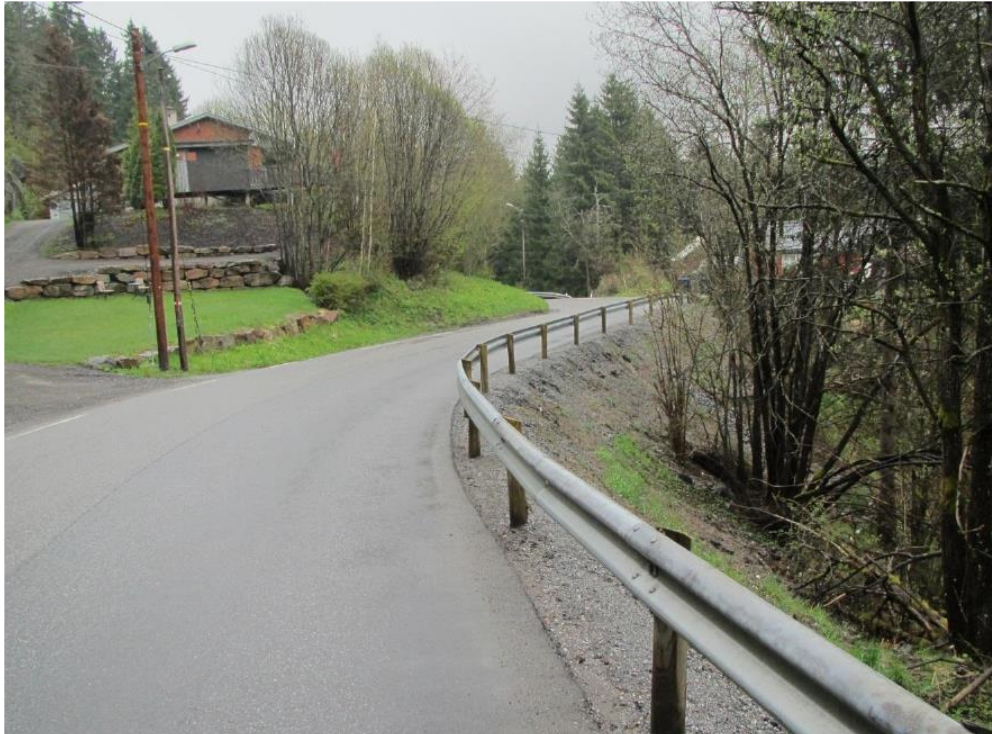
*Figure 57: After strenghtening with foamglass and geogrid (Photo: Jan Vaslestad)*

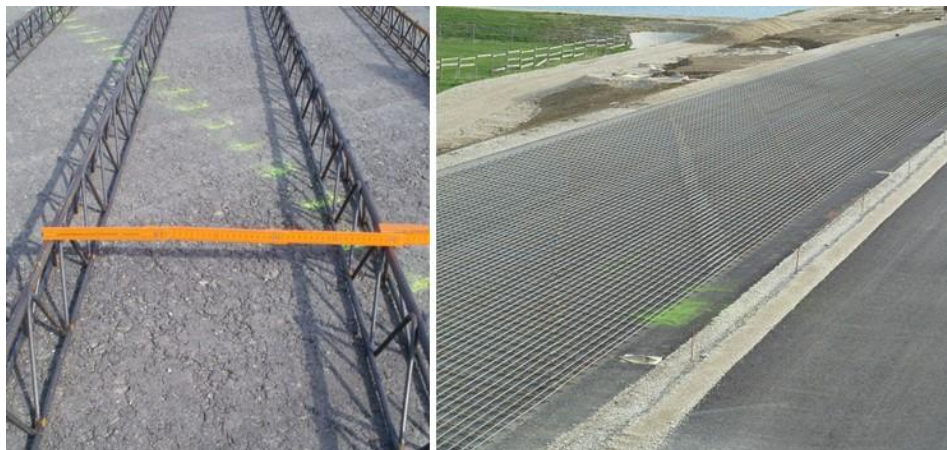
Figure 60: Placed transverse and longitudinal reinforcement

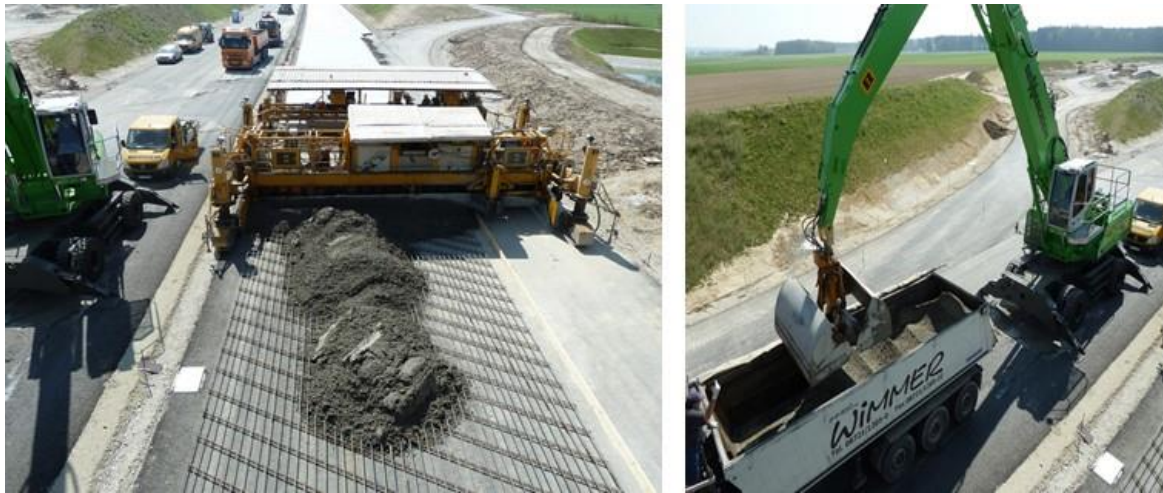
*Figure 61: Concreting of the continuously reinforced concrete slab*

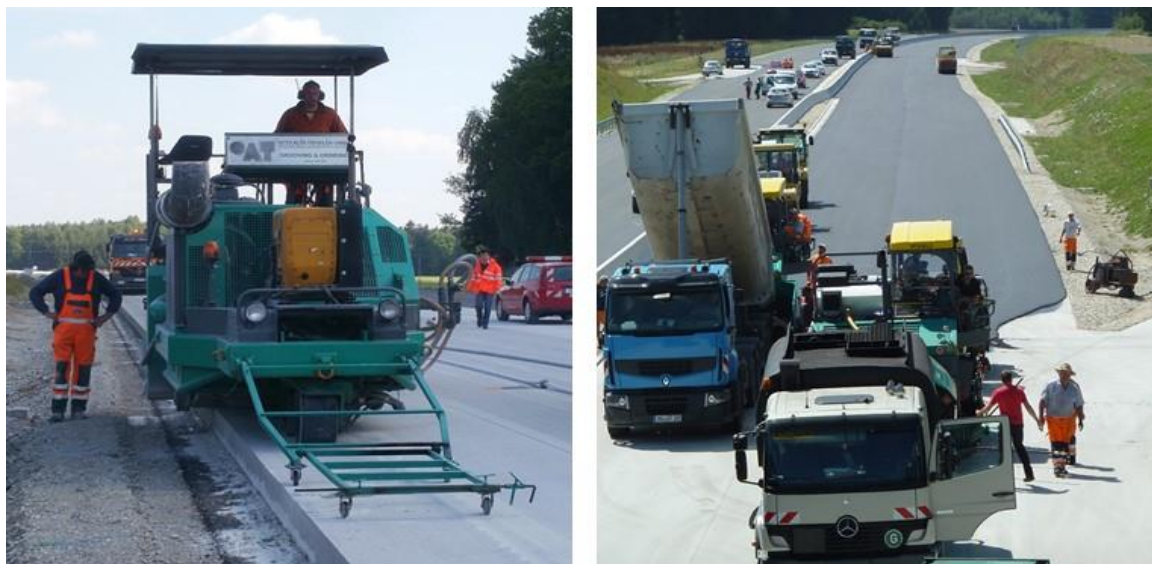
*Figure 62: Production of the grinding texture of the asphalt surface course (DSH-V)*

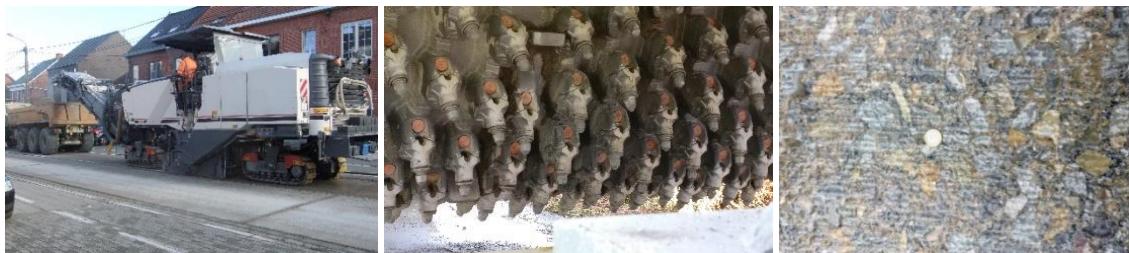
*Figure 69 : Fine milling- from left to right: milling machine – rotating drum equipped with picking tools – result of surface after finemilling (©L. Rens, FEBELCEM)*

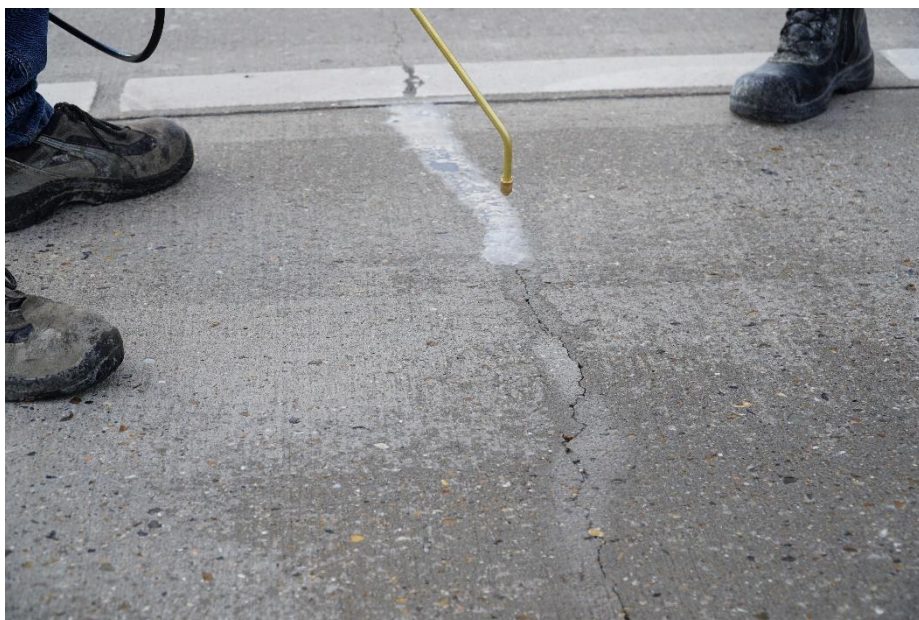
*Figure 75 : Application of the repair liquid on a crack*

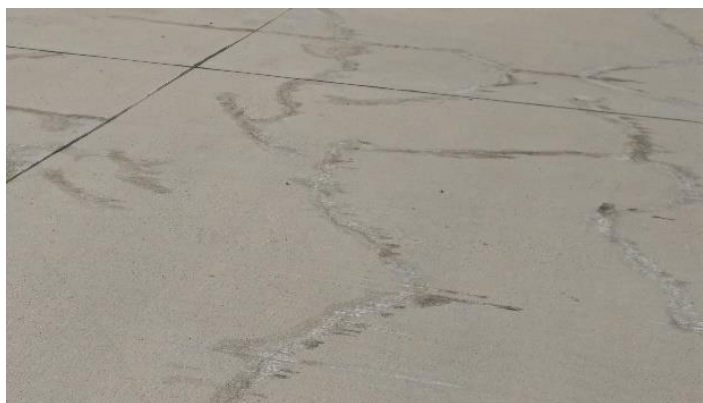
*Figure 77: Shrinkage cracks, right after application of the repair liquid (2020)*

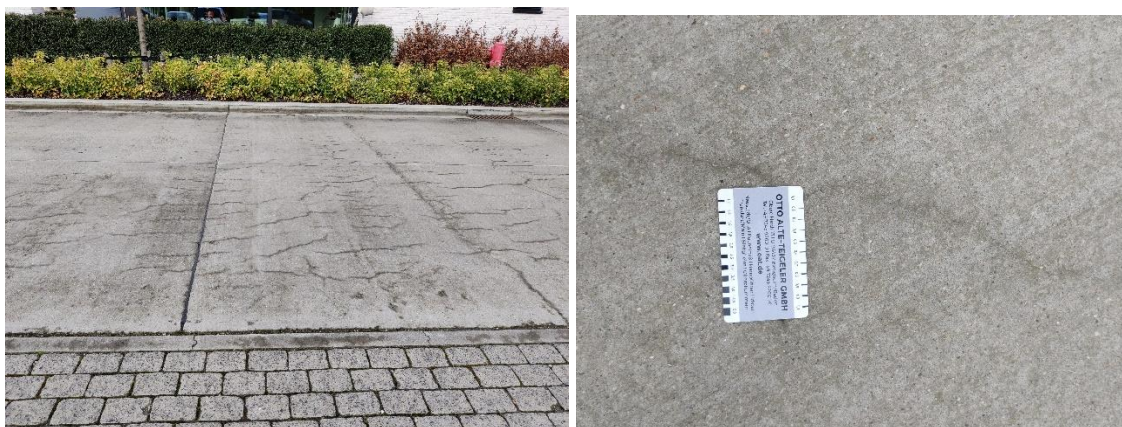
*Figure 78: Situation after 2 years (2022)*

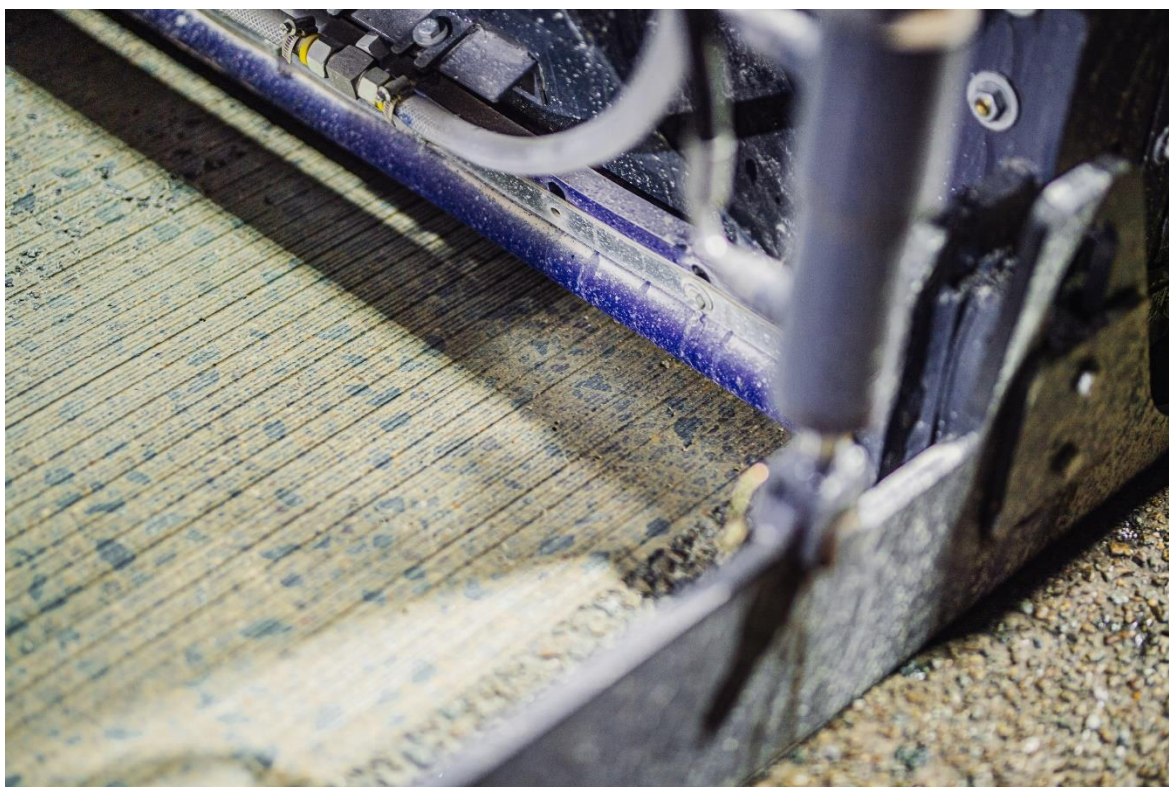
*Figure 81: application of the NGCS profile on the R1  
(picture by Kris Van de Sande, Agency for Roads and Traffic)*

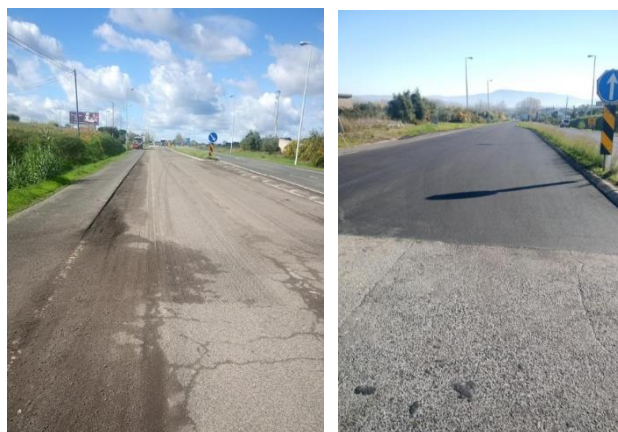
*Figure 88: Typical punctual sanitation works before and after*
