# MEASURES FOR INCREASING THE ADAPTABILITY OF ROAD BRIDGES TO CLIMATE CHANGE

## A PIARC TECHNICAL REPORT

TECHNICAL COMMITTEE 4.2 *ROAD BRIDGES*

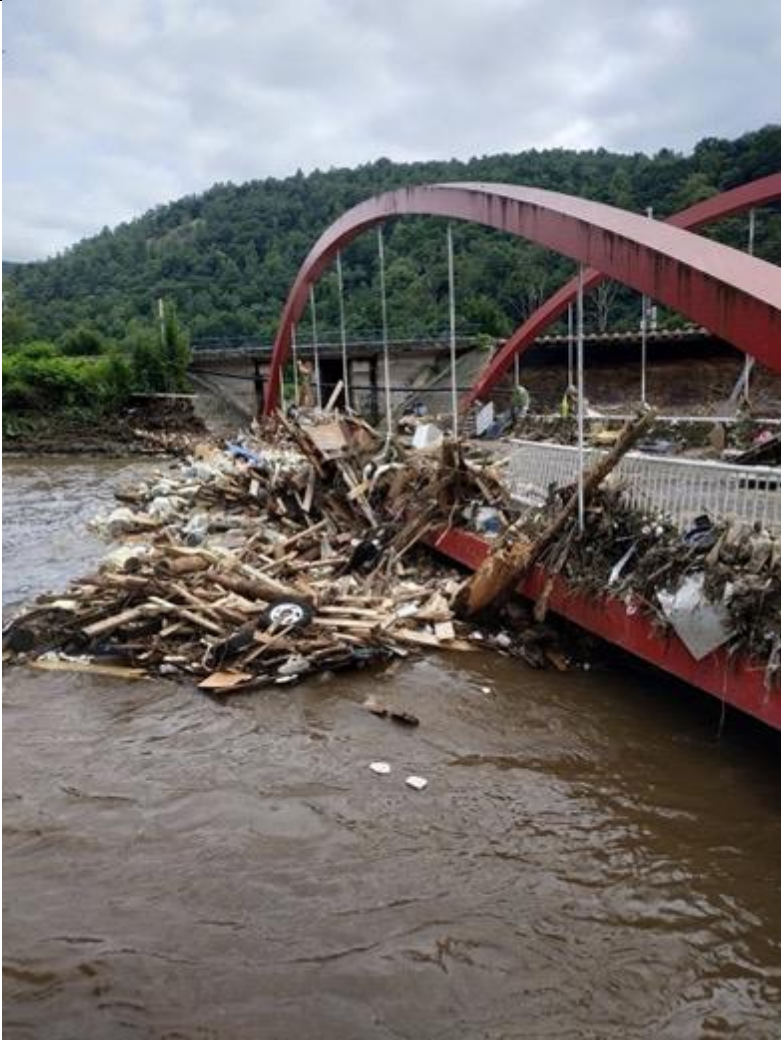
| <b>Description of bridge</b> | <b>Bowstring steel bridge of about 30 m length.</b> |

| #01 Belgium (1): High flooding caused the bridge to move laterally by 0.5 to 1.3 m. | |

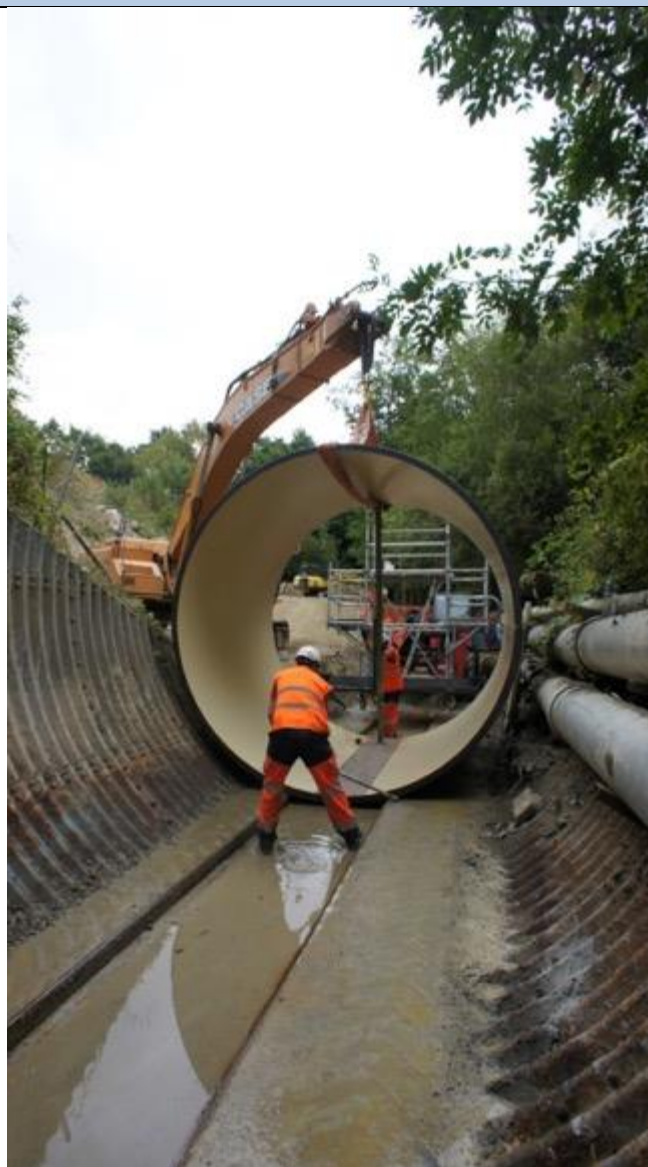
Reinforcement work carried out during the 2015 low water period  
Additional hydraulic works carried out in 2016

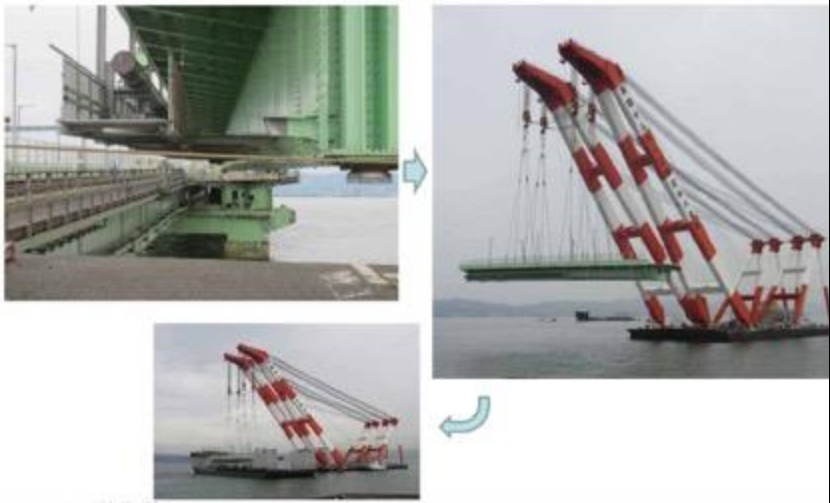
Removal of Girder by FC Vessel

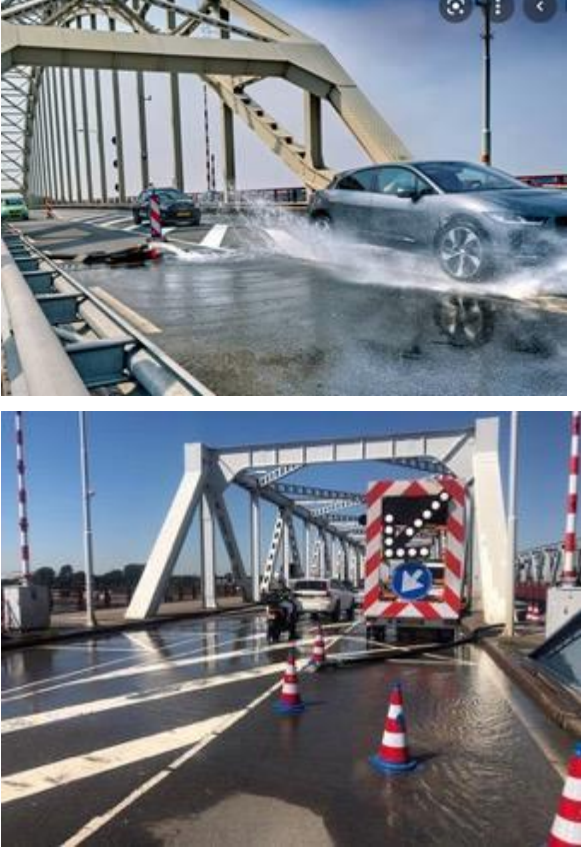
| <p>Picture of the problem</p> | <p>Cooling measurements are required as a temporary solution.</p> |

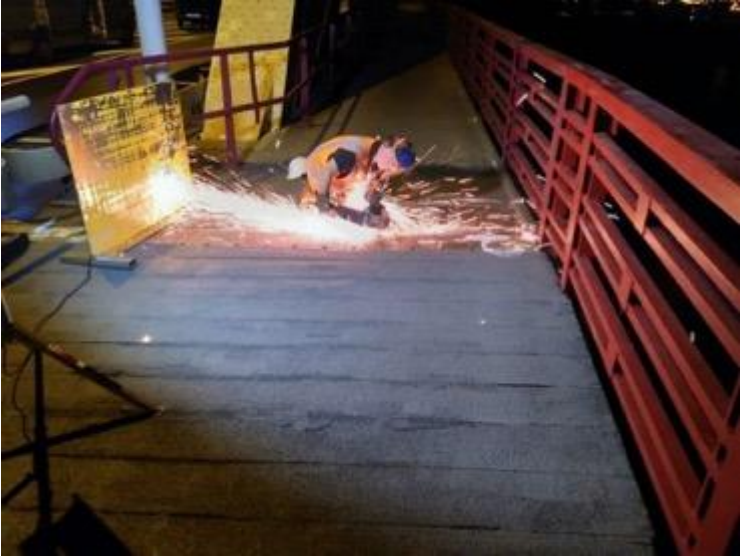
| <p>Answer</p> | <p>Grinding down existing bridges, making the joint at a new bridge adjustable.</p> <p>Shortening the movable bridge as a definitive measurement.</p> <p>Techniques have been developed to quickly grind bridges to the desired joint width, and to post-adjust</p> |

| Pictures of the repair/rehabilitation materials and technologies | Grinding down existing bridges, making the joint at a new bridge adjustable. |

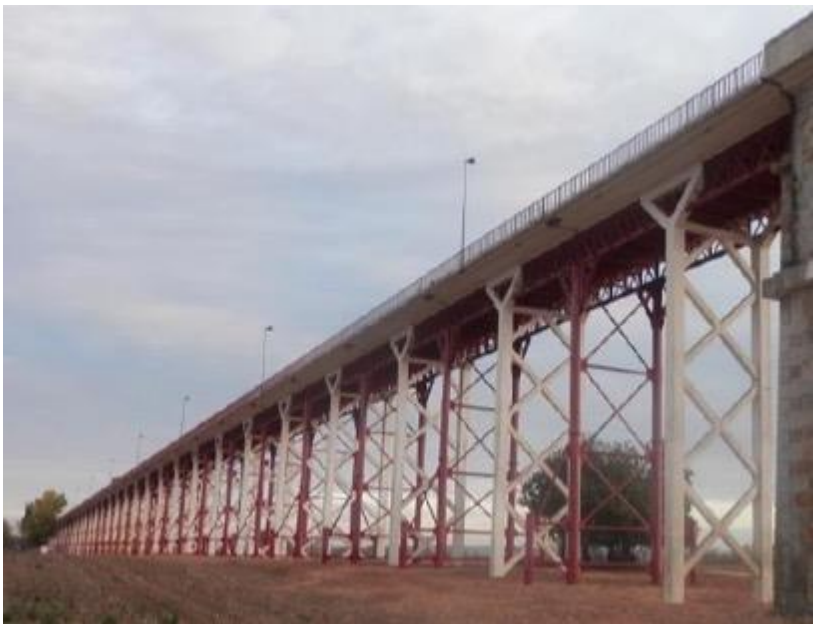
| #17 Portugal (2): Impact on steel bridges due to extreme temperature differences | |
|---|---|
| Picture of the bridge | <p>a) Case 1 – Truss bridge; 3 spans (50 + 60 + 50); Length 160 m</p> <p>b) Case 2 – Truss viaduct; multiple span; Length 570 m</p> |

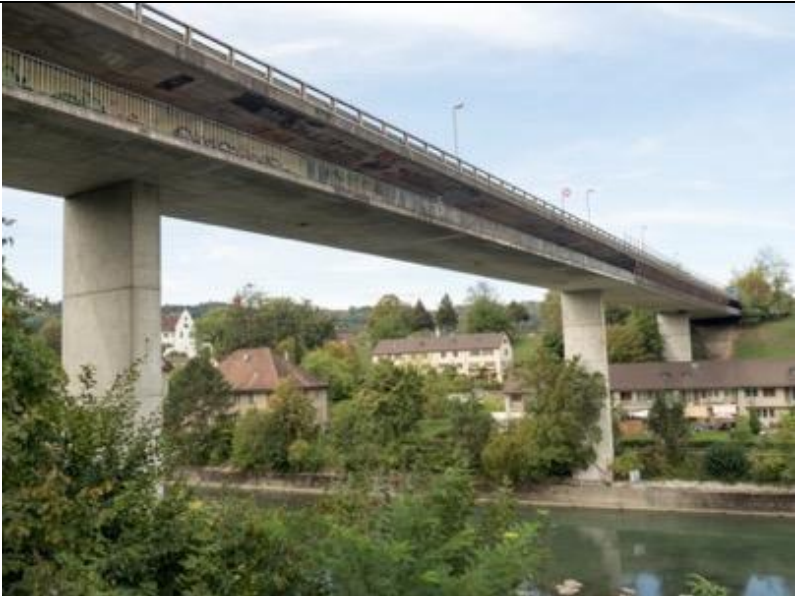
| #19 Switzerland: Pavement and waterproofing of decks were deformed and leaked. | |
|---|---|
| Picture of the bridge | <p>Bridge superstructure, view of the side with 2<sup>nd</sup> deck.</p> |

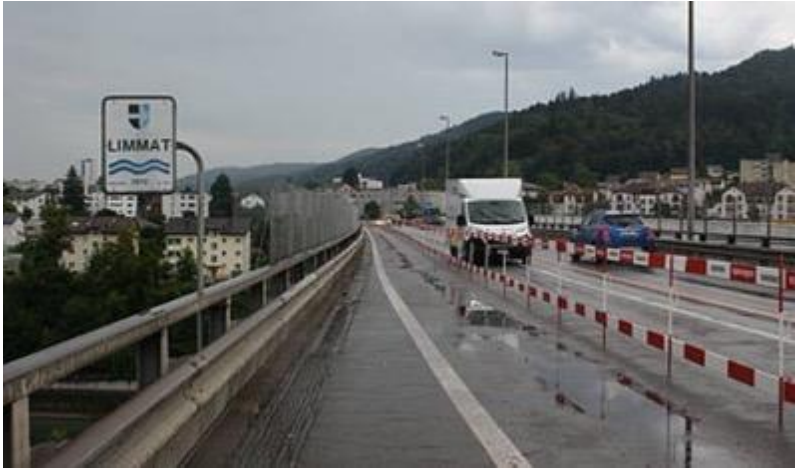
| | <p>The deformations are visible in wet conditions – water shows where the wheels of the cars normally are.</p> <p>In this picture, the water shows clearly the deep deformation in the pavement.</p> |

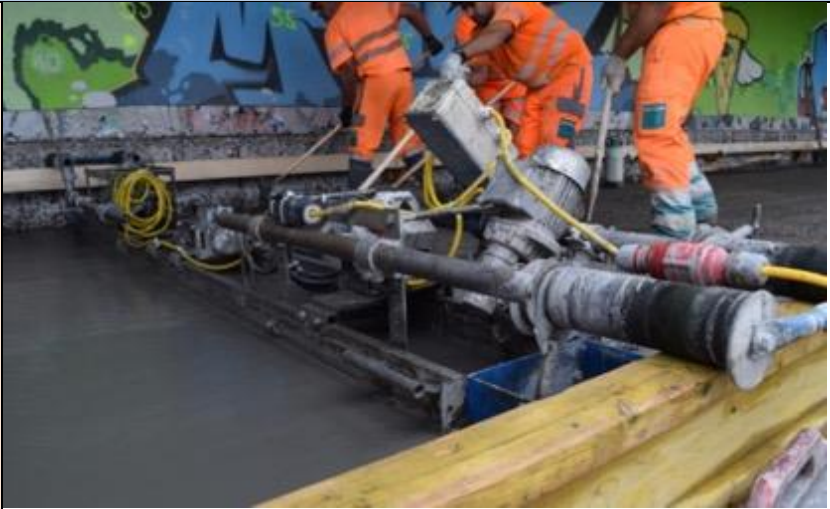
“Tremix” concrete vibrating beam in use on lower deck

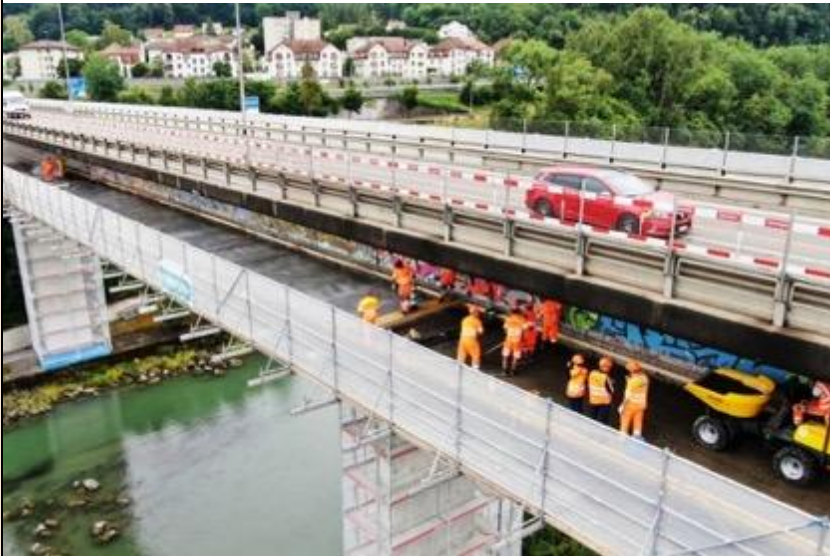
Application of the first layer on the lower deck

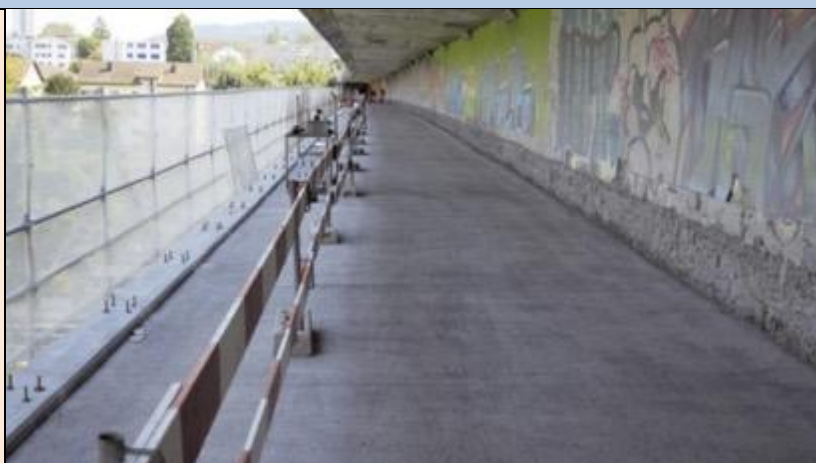
Finished UHPC application on lower deck (rehabilitation measure of the lower part of the web, also in UHPC, not yet executed). Rim with new anchor bolts for the bridge railing, deck pavement.

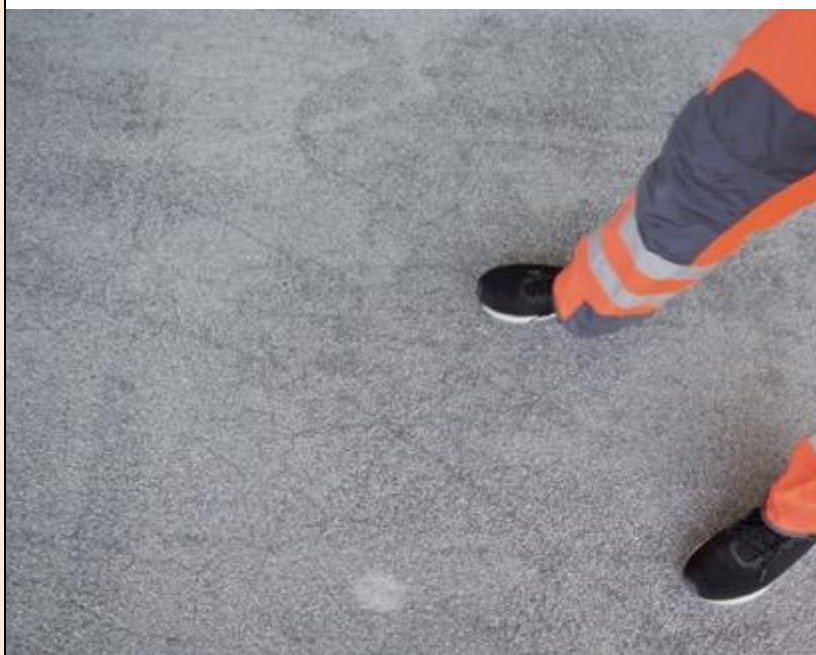
Impression of the obtained surface on the lower deck; a testing probe is visible, too.

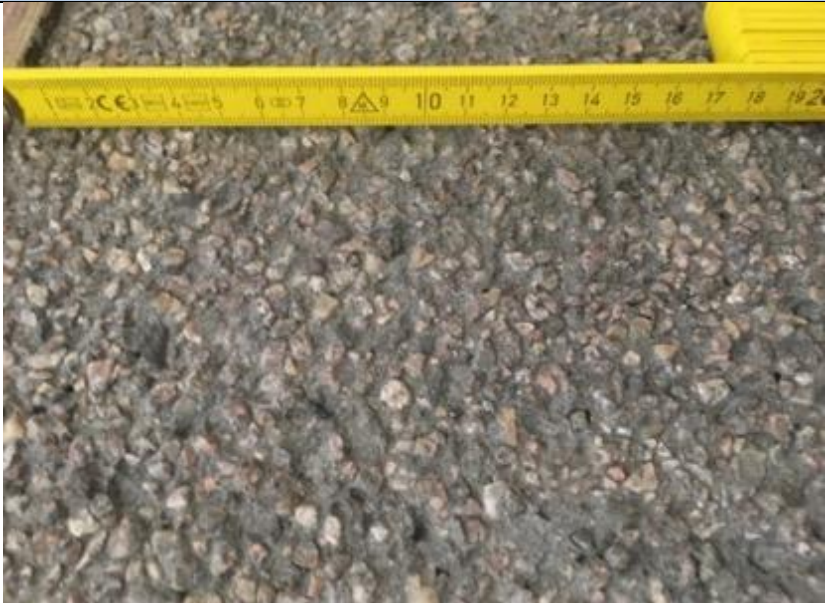
Close-up of the surface, units of the scale are centimeters

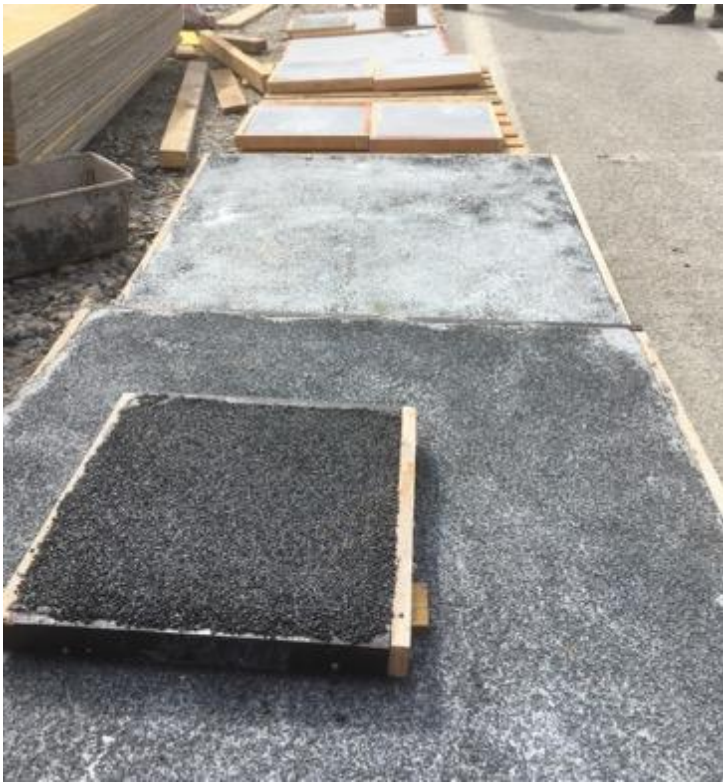
Other samples of the “splittmatrix” made with a different UHPC product.

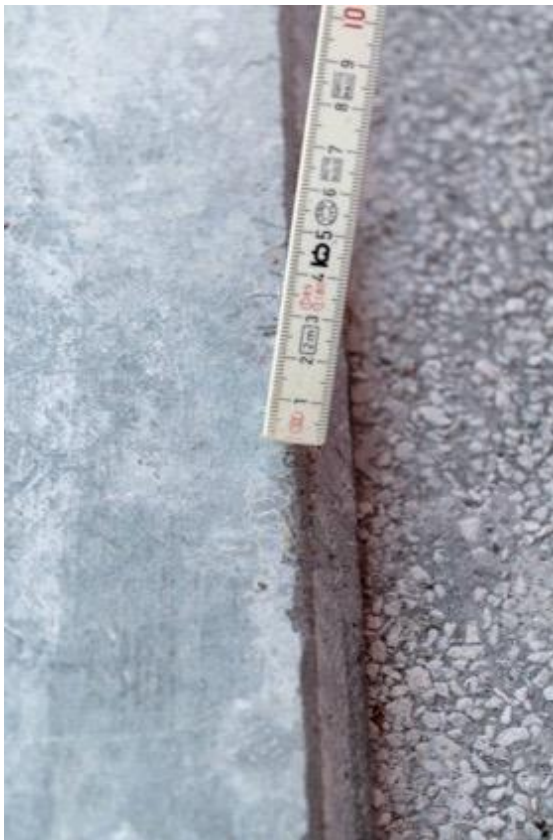
Close-up of the lower rim in UHPC and the pavement in “Splitt-Matrix” UHPC, units of the scale in centimeters

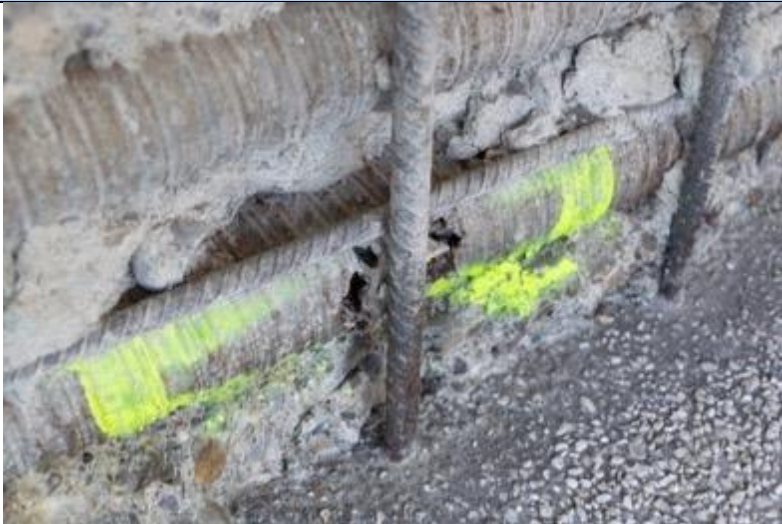
Close-up of the lower part of the outer web adjacent to the UHPC pavement, on a part with corroded duct of one prestressed tendon. The strands were without corrosion. The injection grout was in good condition. The rehabilitation measure consisted of carefully opening the area of the metal duct marked in yellow (a few more locations along the 200 m long measuring bridge at the low areas of the tendons), removing the grout material (possibly contaminated with de-icing chlorides), sealing the cladding tube with the same metal duct, injecting this part under pressure and placing a 5 cm (2") thick UHPC layer in front of the entire lower part of the bridge. This layer of UHPC was also used to fill all removed parts of concrete around the ducts.
