# FORENSIC ENGINEERING FOR STRUCTURAL FAILURES

A PIARC TECHNICAL REPORT

TECHNICAL COMMITTEE 4.2 *BRIDGES*

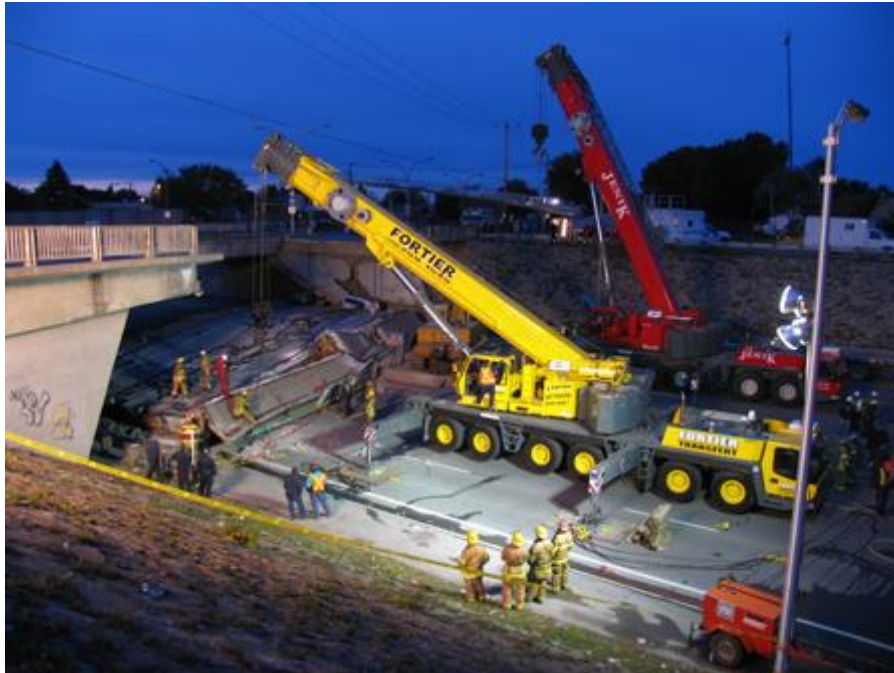
*Figure 7: First responders investigating the site of the De la Concorde overpass collapse outside of Montreal, Quebec, Canada on September 30, 2006.*

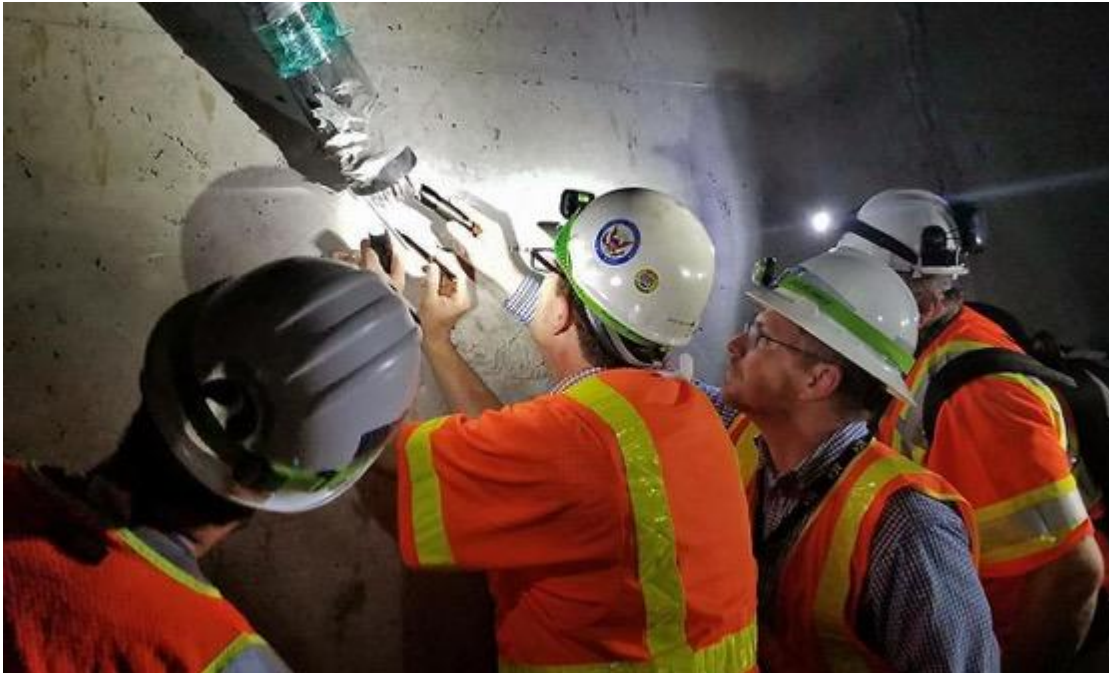
*Figure 8: A group of engineers and scientists investigating the failure of a post-tensioning tendon.*

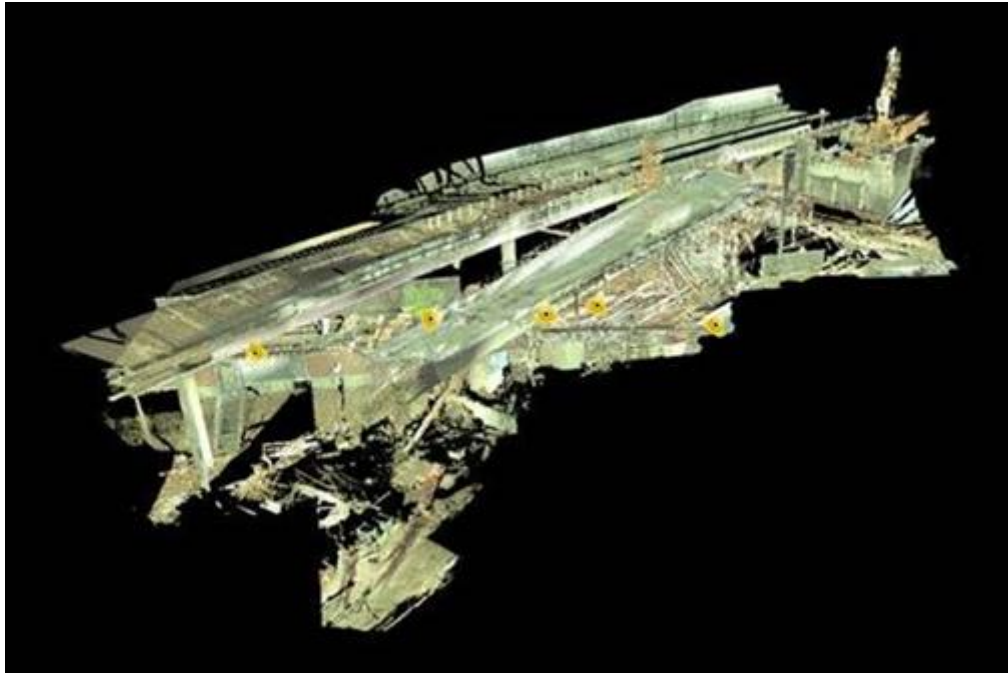
*Figure 9: LIDAR point cloud documenting the position of the F3 Murbrücke Frohnleiten Bridge wreckage which collapsed in Austria on February 21, 2015.*

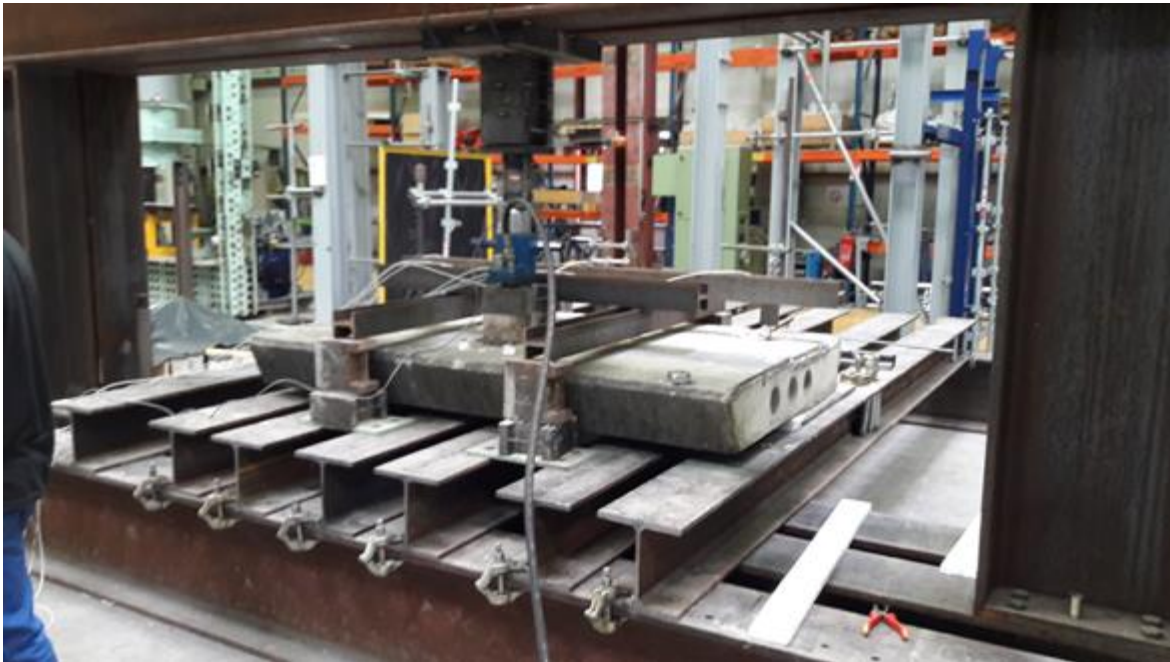
*Figure 11: Scaled component experiments used to support the Cofiroute investigation a failed precast corbel sidewalk to deck slab connection at the Elancourt Structural Engineering Laboratory in Paris, France.*

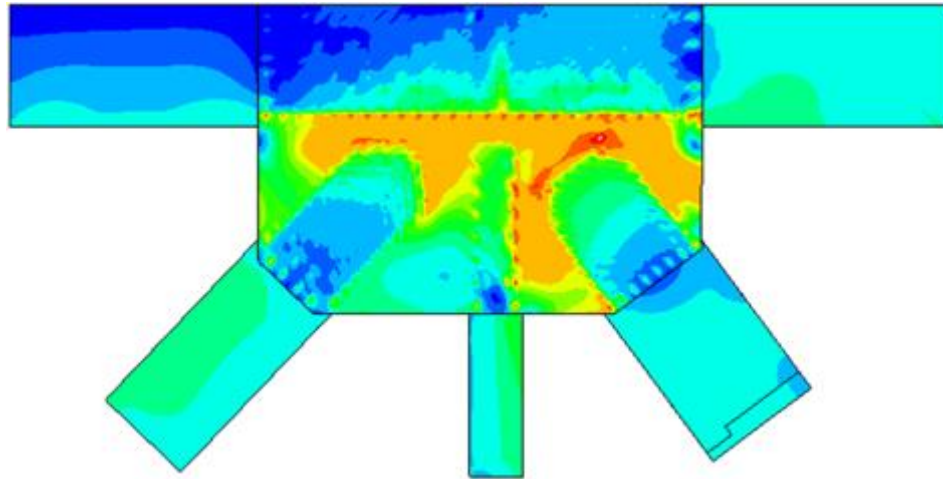
*Figure 12: Finite Element Analysis of a gusset plate connection on a steel truss bridge.*

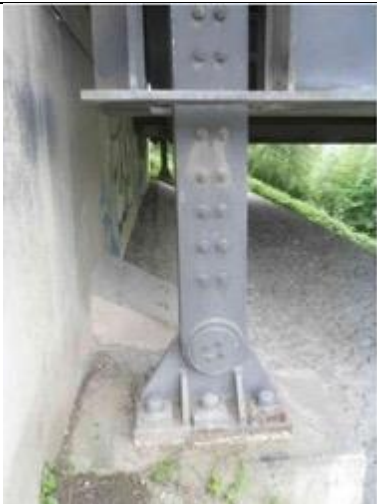
Picture of the failure

| Case : Lixhe Bridge | |
|---|---|
| Answer | <p>One of the 2 abutments is characterised by the presence of negative reactions varying from 1400 kN (under dead load) to 2300 kN (under full load) for each of the 2 supports of this abutment. These connecting rod bearings are connected to the foundation by 6 post-tensioned Dywidag bars (36 mm).</p> <p>In the early morning of February 8, 2018 (before 6:15 am), the anchors of one of the two abutment supports broke, causing the deck to partially lift. The height of the uplift in a stabilised situation was approximately 65 cm. It is likely that in the dynamic phase of the uplift, a height of approximately 80 cm was reached, given the traces left on the concrete.</p> |

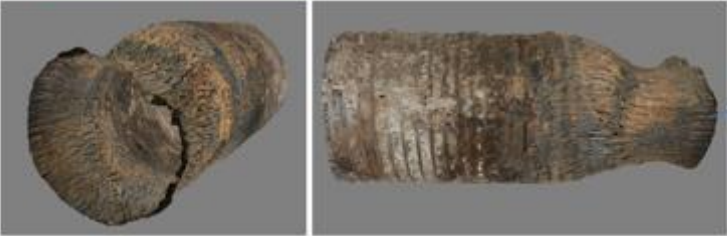
| Case : Lixhe Bridge | |
|---|---|
| Answer | <p>Corrosion of the dywidag bars</p> <ul style="list-style-type: none"> <li>Dywidag PT bar <math>\phi</math> 36mm</li> <li><math>f_y = 1100\text{MPa}</math>, <math>f_u = 1250\text{MPa} \rightarrow N_u = 127\text{t}</math></li> <li>Post-tensioning : 80 T (initial value)</li> <li>No old ruptures (no corrosion on the rupture face)</li> <li>Main origine : <u>severe section reduction due to corrosion</u> (2-3 PT bars)</li> </ul> <div style="text-align: right;"> <div style="border: 1px solid black; padding: 2px; display: inline-block;">Deformed by hammer</div> </div> |

| Case : Lixhe Bridge | |
|---|---|
| Answer | If possible, avoid the use of dywidag bars because it is impossible to know if there is any corrosion. |

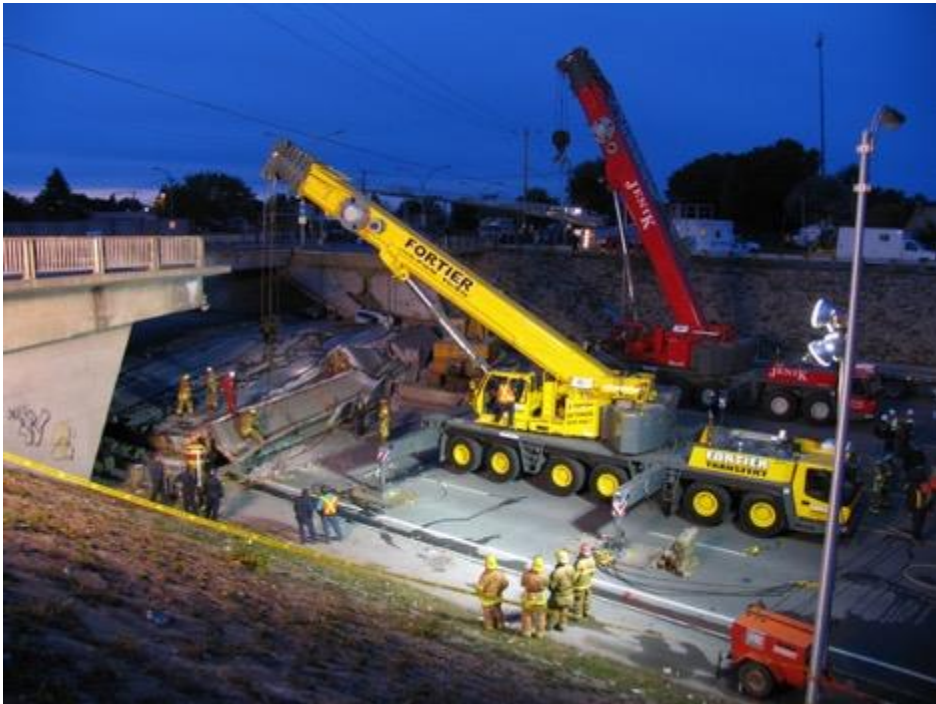
Rescue operations on the collapsed center span

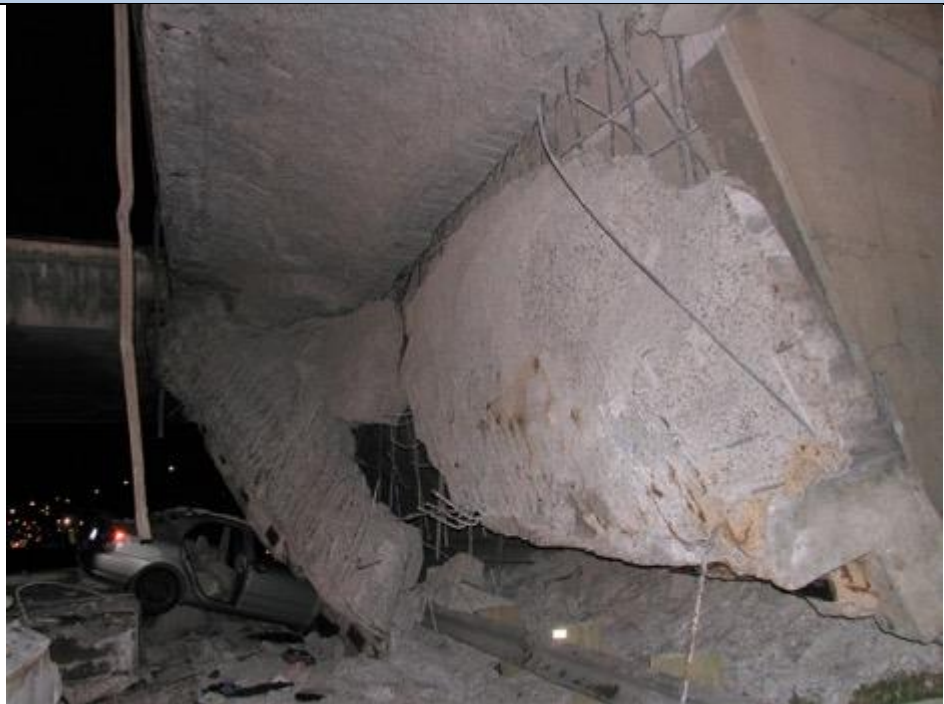
Collapsed cantilever section of the East abutment. The deck joint profile is still in place and the center span bearing pads are visible at the bottom right of the picture

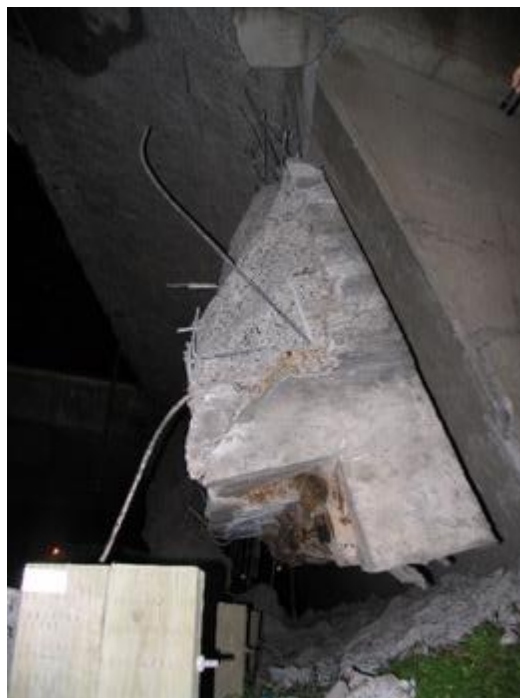
Collapsed cantilever. The corbel is at the bottom, laying against the abutment wall, hanging from the bottom mat of rebar

| Case : De la Concorde Overpass | |
|---|---|
| Answer | <p>Poor concrete quality in a critical part of the bridge, heavily exposed to de-icing salts and very hard to inspect or repair.</p> <p>Poor quality control on site during construction, that resulted in rebar being misplaced. Since no records were made of the as built structure, the engineers inspecting and managing the bridge never had the knowledge of that fact. The concrete cantilever and the faulty rebar placement allowed the cracking to progress inside the full depth concrete slab that eventually failed in shear</p> <p>Poor management of the deterioration process regarding repair or rehabilitation work that was not done in a timely manner. Some repairs (deck joint replacement) may even have contributed in aggravating the cracking at the early stages.</p> |

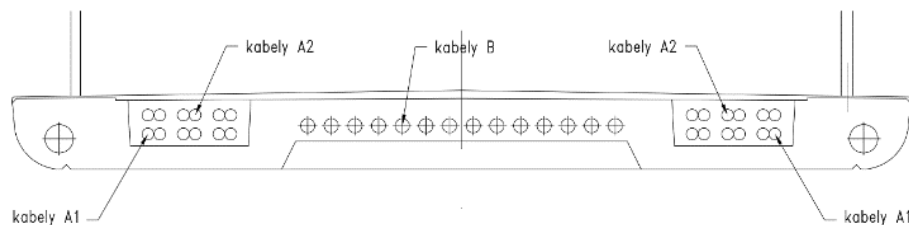
In December 2017 unforeseen sudden collapse occurred. Actually no live load was present on the bridge during collapse (only 4 people on the bridge, fortunately no casualties).  
Immediate cause of the collapse was apparently a sudden fracture of both bearing tendons (A) and prestressing tendons (B).

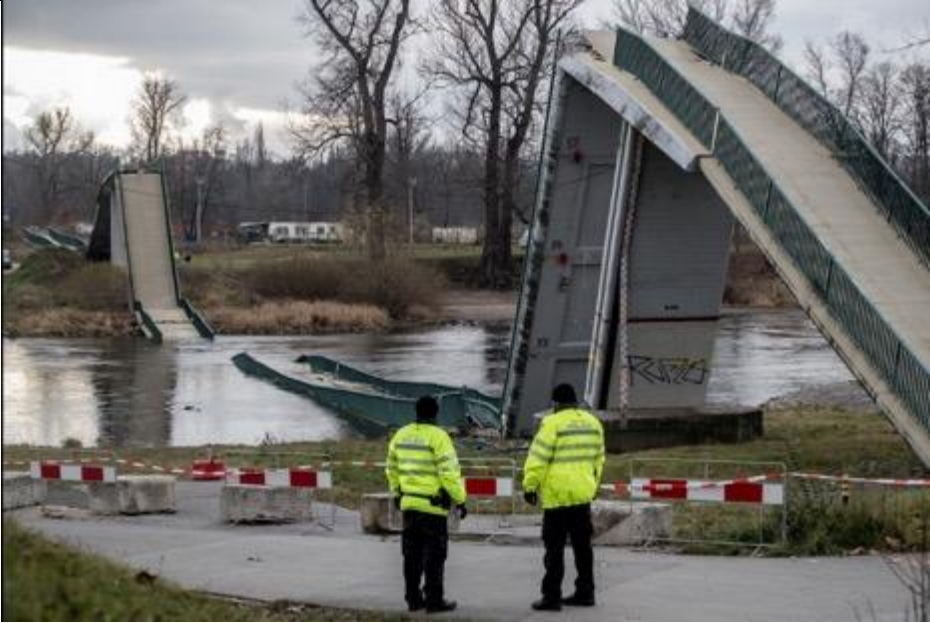
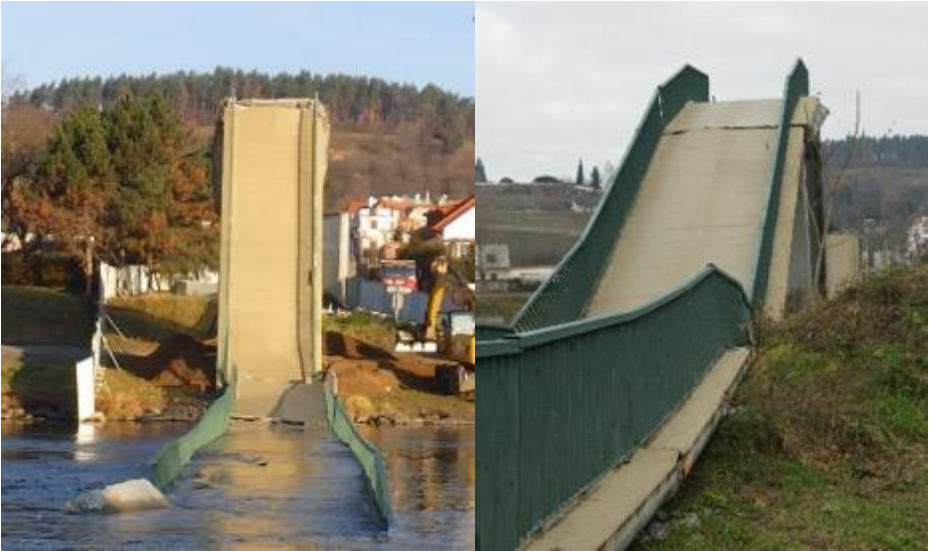
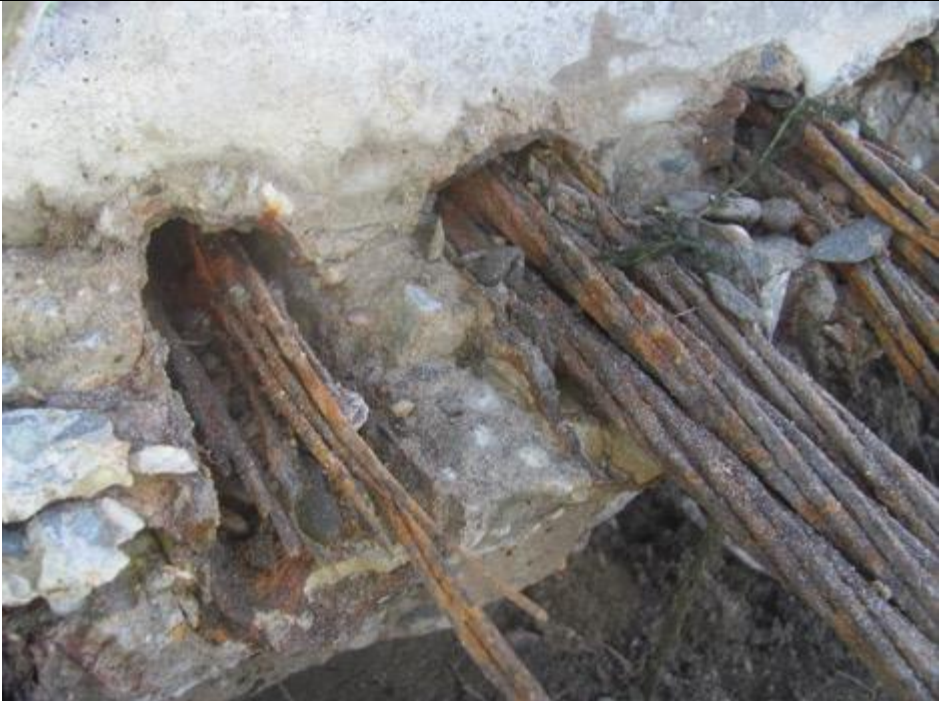
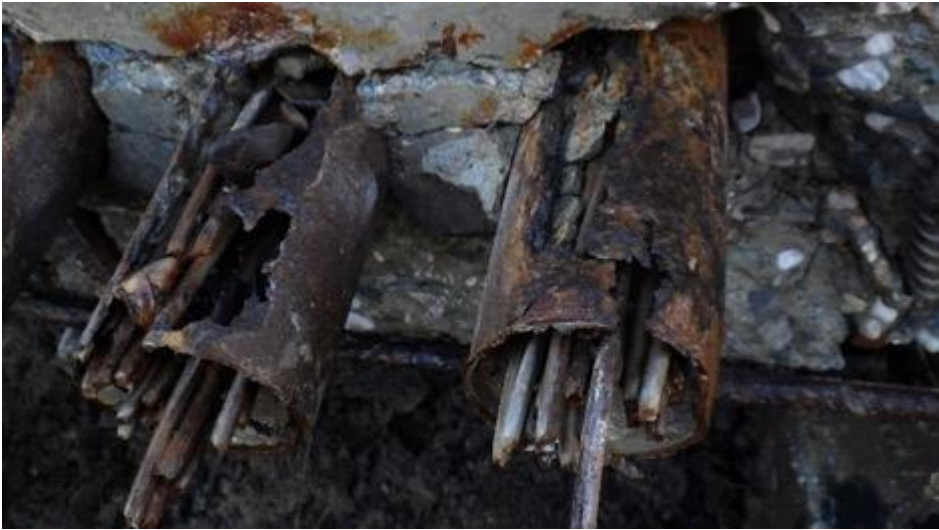
| Case : Troja stress ribbon footbridge | |
|---|---|
| | <p>From the first moment it was almost certain that the fracture of the tendons was caused by its deterioration (corrosion). The question was, what was the cause of such serious corrosion and why there were no signals in change of the bridge behaviour prior to collapse.</p> |

| Case : Troja stress ribbon footbridge | |
|---|---|
| Answer | <p>Non-public information (trial is currently on the way)</p> <p>The sudden fracture of bearing tendons was caused by unpredicted scale of corrosion of these tendons. This corrosion was provoked by intrusion of water (containing de-icing salt) through the worn insulation layer inside the trough, where the bearing tendons were placed (filled by cast-in-placed concrete following the tensioning the second half of these tendons (A2), the concrete was of poor quality and not evenly and fully filled out the trough), and also through the joints between segments.</p> <p>Because the worst corrosion of the A1 strands had been developing only locally inside random holes, full of water, hidden in the bottom of the trough, subsequent local overstressing of strands was limited to short sections, thus it did not result in change of overall structural behaviour (no significant development of the joint openings, no sag increment). Also this mechanism of the strand damage was not necessarily accompanied by an increase of water penetration through the joints, as the local defect could be off the joint. So the progress of the strand damage could remain undetectable. Once the local overstress inside the weakened strands exceeds the strand actual limit, the first wire/strand cracked, the force was redistributed to remaining strands and due to domino effect the structure collapsed.</p> <p><i>Note: above are not official conclusions, but only possible explanation</i></p> |

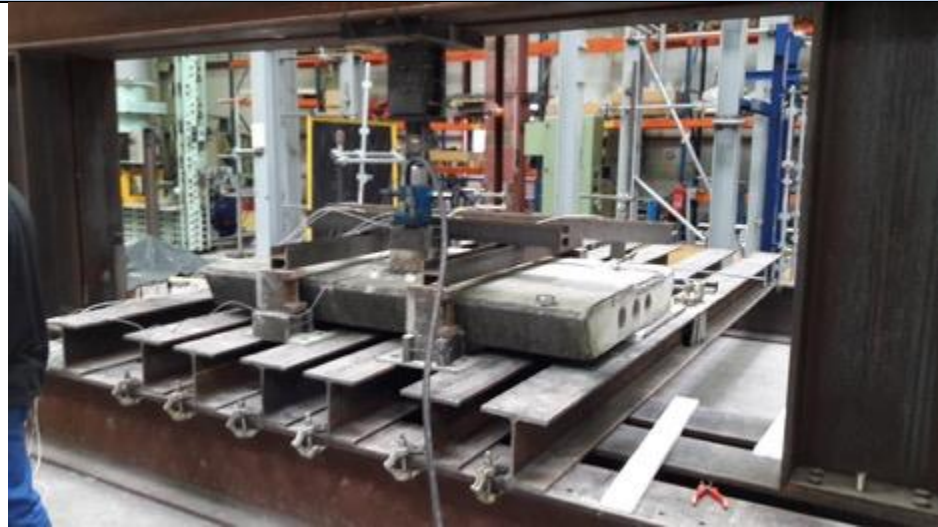
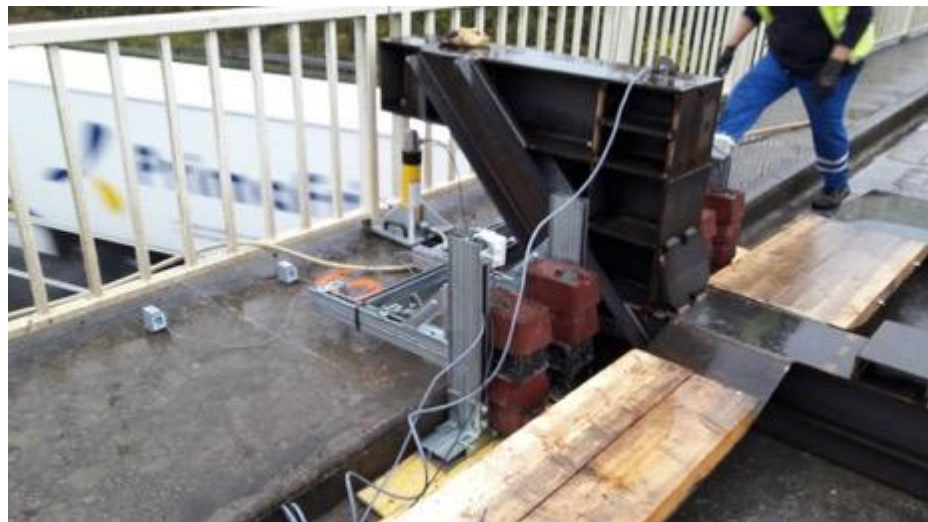
We were able to follow the loading test in real time, check the impact on the anchors, reproduce a failure of some anchors to understand the impact on the overall failure.

The on-site tests could thus be carried out in complete safety.

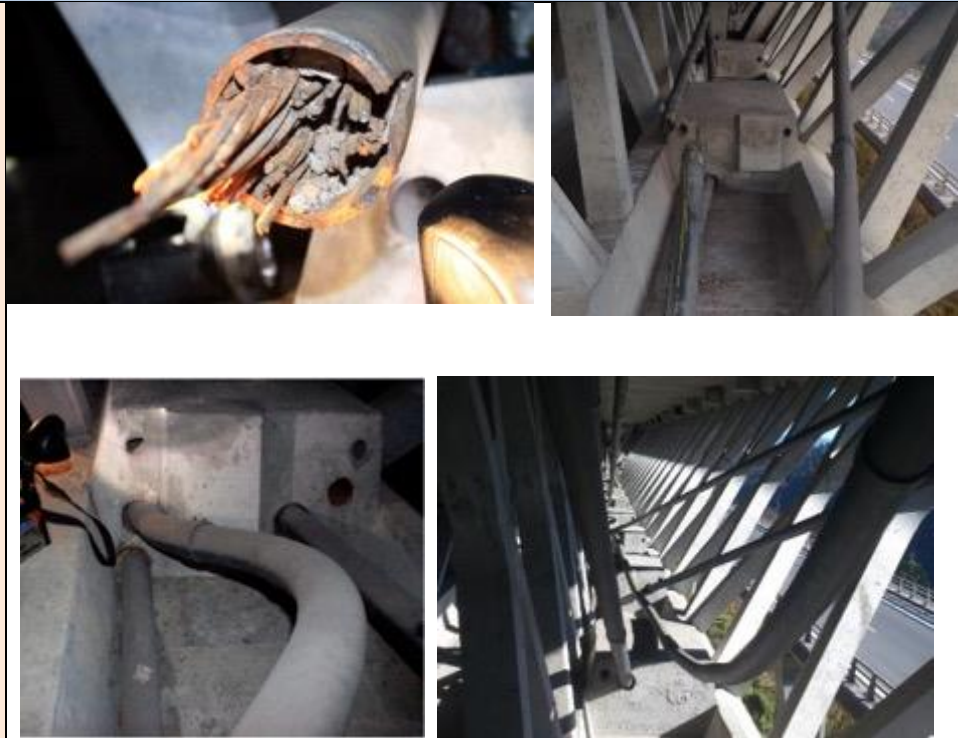
| <b>Case : External Prestressing Tendon Failure</b> | |
|---|---|
| Answer | <p>Following a maintenance visit on the highway network, a failure external prestressing cable was discovered on 02 November 2015.</p> <p>Following an examination of the fracture point, it was identified that the failure was due to corrosion of the steel cables due to a leakage defect of the HDPE ducts that was not visible during the visual inspections.</p> |

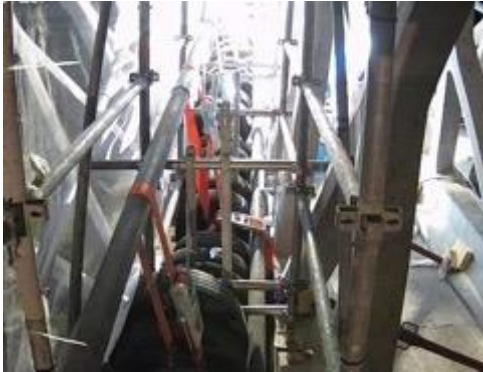
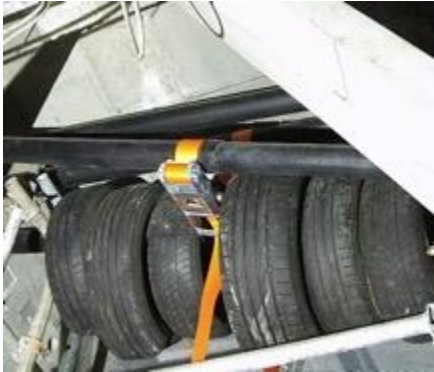
| Case : External Prestressing Tendon Failure | |
|---|---|
| Answer | <p>The corroded cable once detected, with the abundant corrosion of the exposed steel cables, had to be secured to avoid a sudden failure and risk to the personnel involved. Investigations had to be stopped until the cable was suddenly cut for replacement.</p> <p>In order to prevent the cable from being whipped under sudden breakage, the cable was tied with straps and tires to enable a damping system to be achieved.</p> <div> </div> |

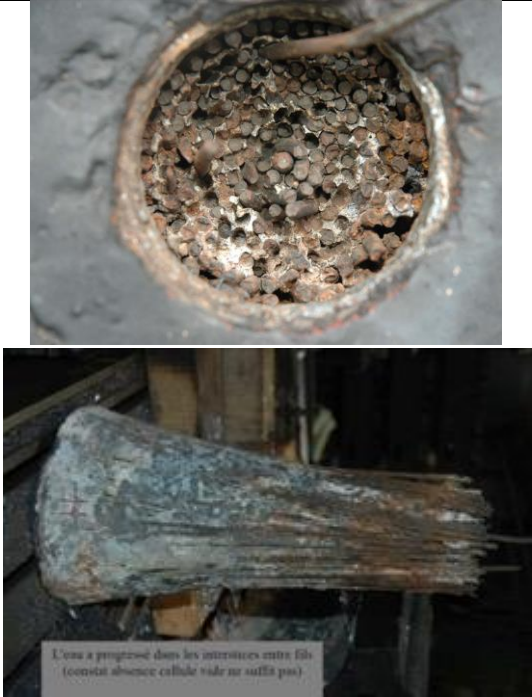
| Answer | On 11 September 2007, a failure in a main cable carrying the structure at an anchor base was observed. |

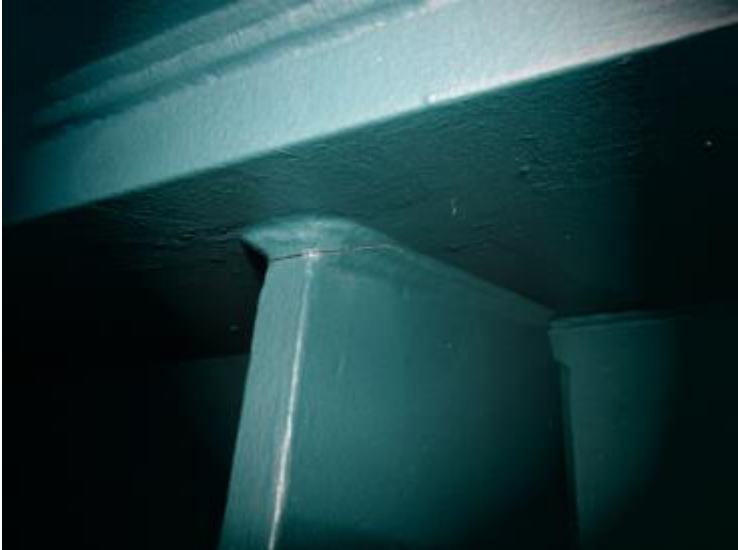
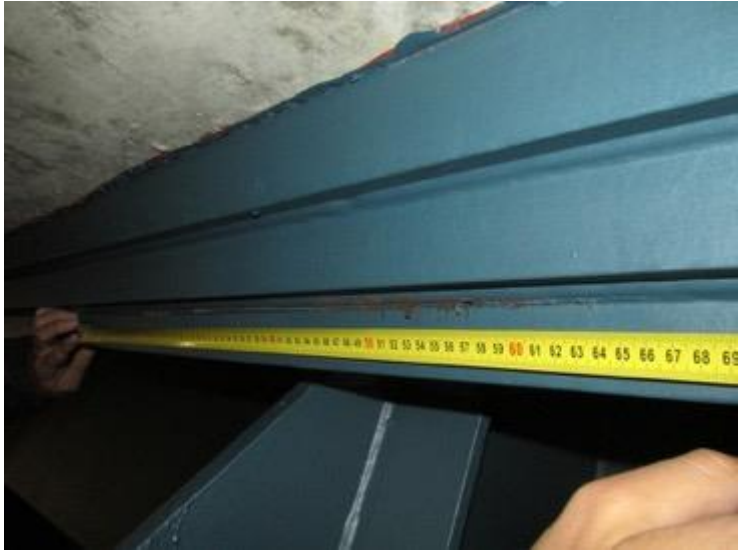
| Case : Bridge over the river Elbe in Hohenwarthe | |
|---|---|
| Answer | <p>According to the prepared expert opinion, the following reasons have been identified to be responsible for the cracks:</p> <p>1) During the construction of the structure, first, the steel components for the box girder were produced and brought into position. To transfer the loads from the formwork carriages required for concreting, steel girders made of double-T sections were welded on the top of the steel flanges at the positions of the transverse frames. These were shortened later, but are mostly concreted into the roadway slab.</p> |

| Case : Bridge over the river Elbe in Hohenwarthe | |
|---|---|
| | <p>In order to avoid local plate bending of the main girder web in the area of the free cut during the construction process, temporary bracket plates are connected from outside, which transfer the released horizontal forces from eccentric traffic loading into the transverse frames in a controlled manner. After the repair of the joint, the horizontal loads are taken up by these joints and the bracket plates can be removed.</p> <p>Subsequently and after analysing the four test joints, starting in 2020, the refurbishment of the remaining areas is done.</p> <p>During the construction work, the traffic on the respective structure is limited to two lanes. The vehicles may use the centre of the roadway slab to minimise torsional stress.</p> |

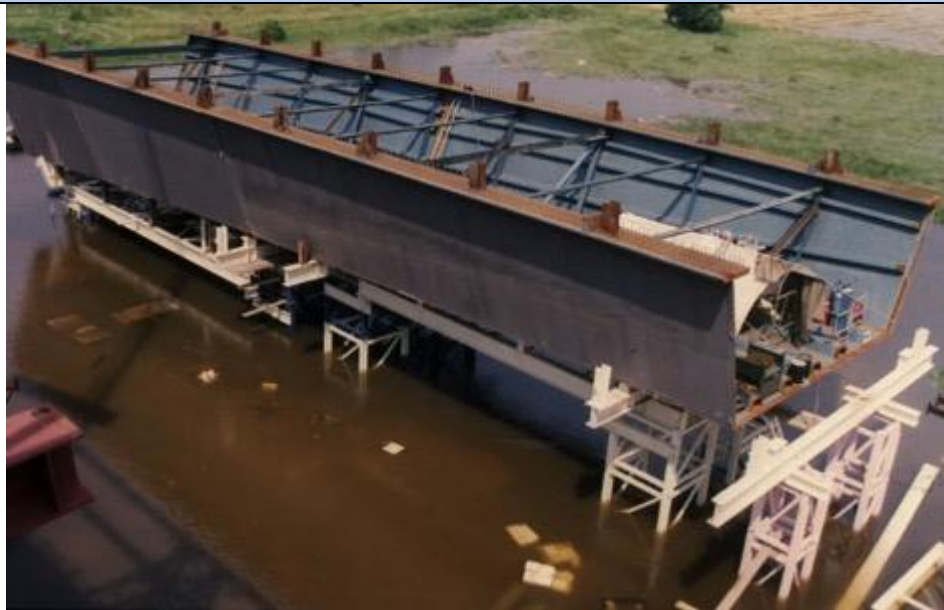
Based on code assumptions, the structural analysis of the structure assumes hinges between the box girder and the concrete slab. In practice, this assumption cannot be confirmed, because when the steel profiles are set in concrete, there is a rigid joint that can absorb high loadings (moments).

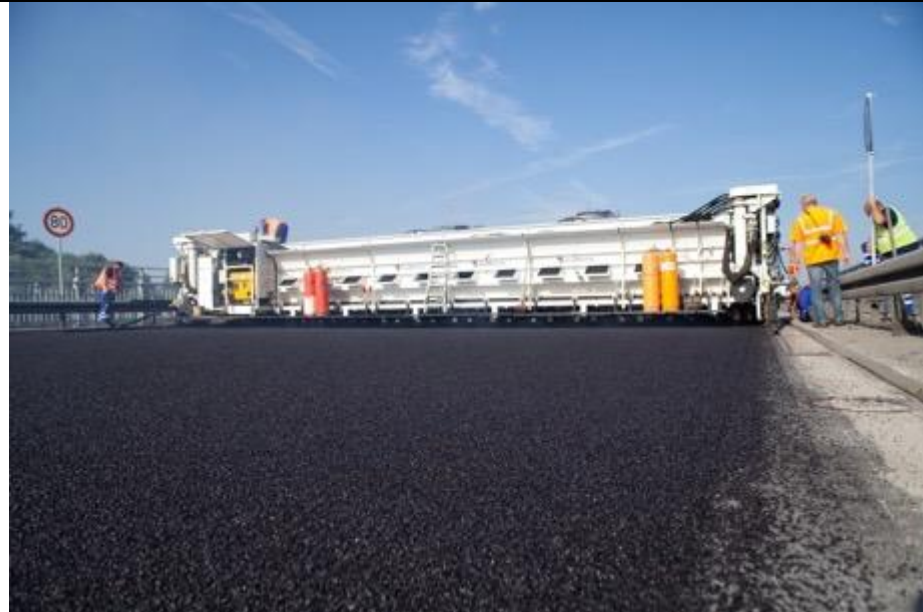
3) The renewal of the roadway slab in the summer of 2013, which was considered an unusual event, also played a role for the occurred damage. The temperature with which the material was applied created significant tensions in the roadway slab. Corresponding load assumptions were not taken into account for the original static calculation of the structure. Due to the unequal distribution of temperature in the roadway slab, the roadway slab tries to bulge out. Additional stresses occur in the upper connections of the transverse frames. The thereby induced forces are probably not the main reason for the damage, yet they may have been the reason for visible cracks in the pre-damaged areas and for the acceleration of the damage development. This also explains why no cracks were visible during structure inspections before 2014.

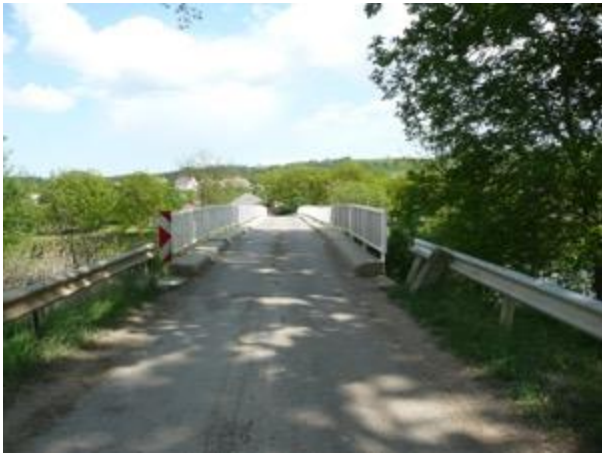
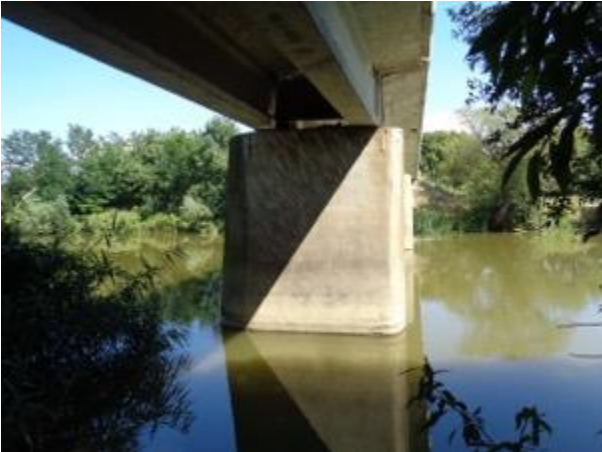
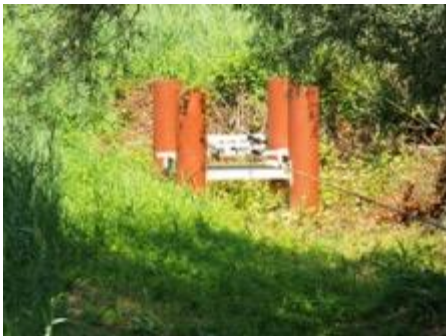
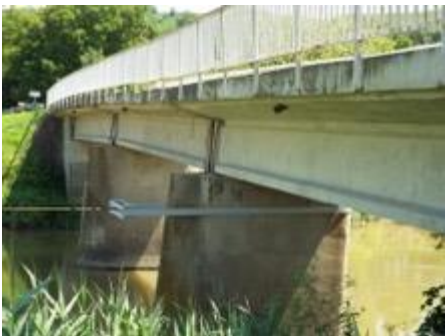
| <b>Case : Hernad Bridge at Pere</b> | |
|---|---|
| Answer | <p>A main bridge inspection in 2016 showed that the right bank river-pier has been tilted to the downstream side. Earlier main inspections also showed a tilting tendency but this process reached such an extent in 2016 that annual detailed geodetic (monitoring) survey was prescribed. In 2018 it was proven that the rate of inclination accelerated so that the bridge had to be closed immediately.</p> <p>The river did not show any unusual flow conditions at an average water level, so no degeneration of the riverbed and no undermining of the pier could be inferred.</p> |

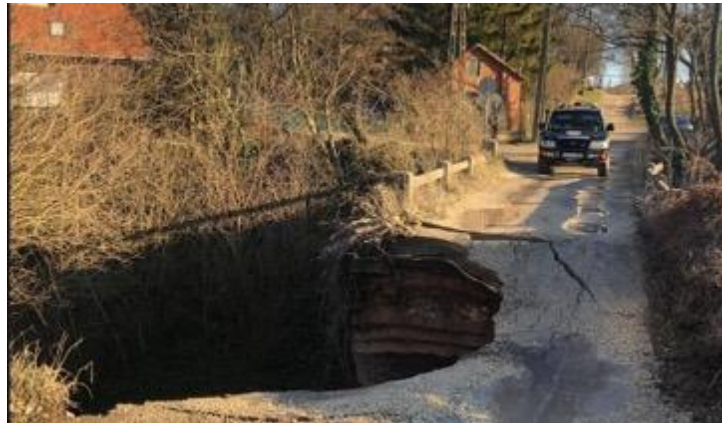
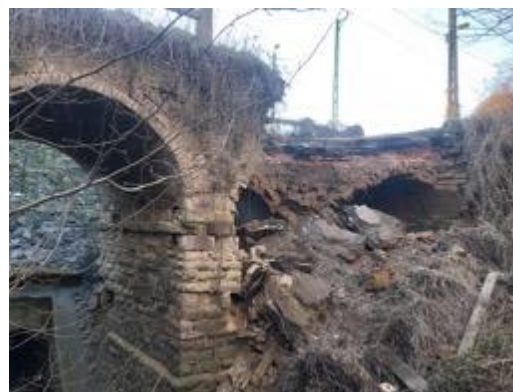
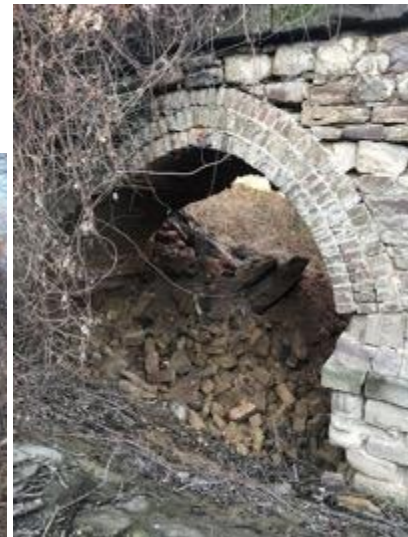
| <b>Case : Piliscsaba Masonry Bridge</b> | |
|---|---|
| Answer | <p>In February 2020, one of the spans suddenly collapsed without any prior notice. Approx. half width of the roadway disappeared in the pit formed by the collapse.</p> <p>There was no external effect/impact at the time of the failure (flood, heavy vehicle, etc.).</p> <p>Fortunately, at the time of the collapse, no one was on/under the bridge, so no injuries were detected.</p> <p>The Civil Guard Service quickly closed the road physically in order to prevent any accidents.</p> |

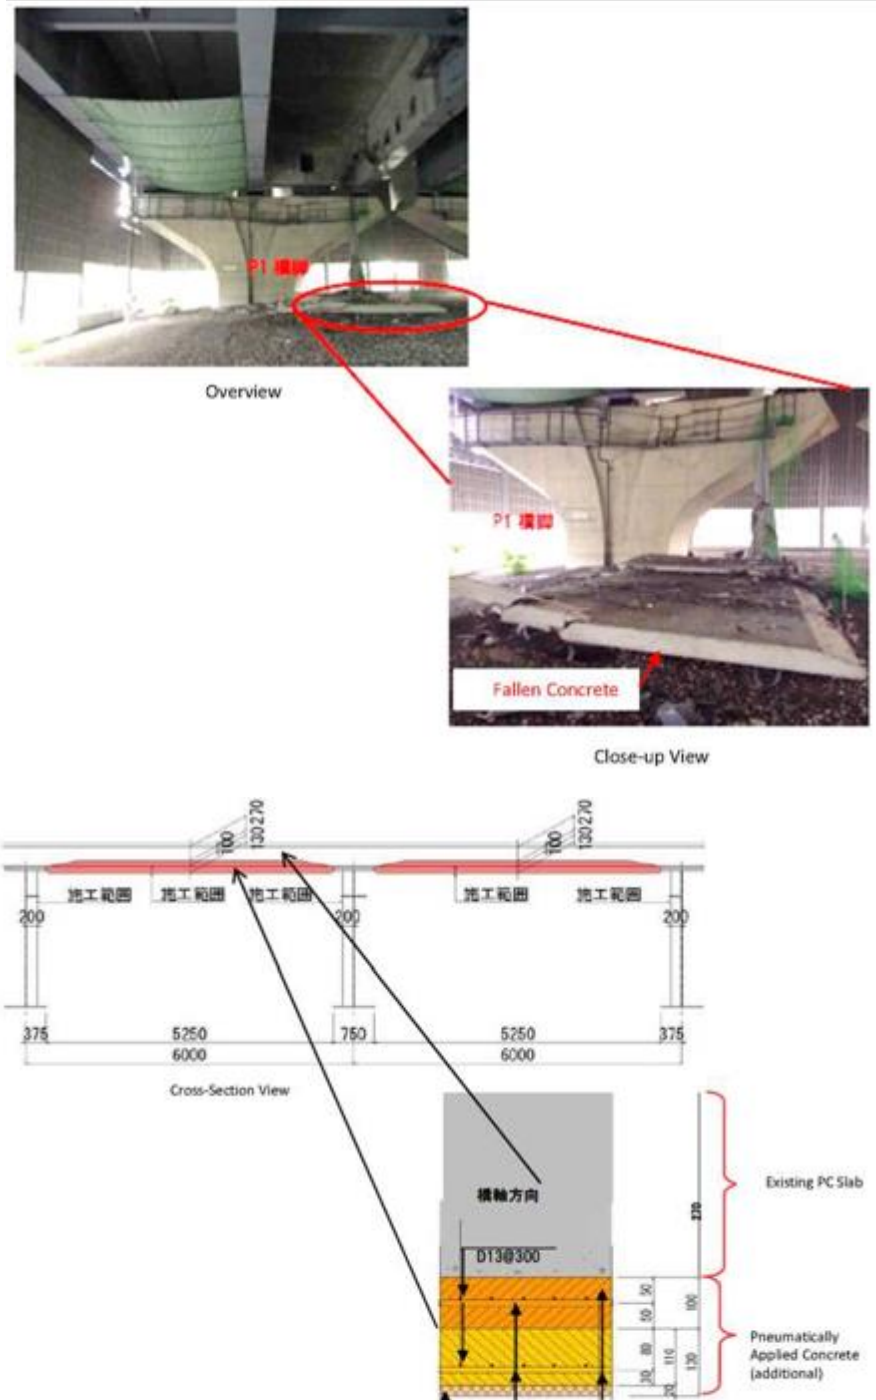
| <b>Case : Spray Applied Concrete Failure</b> | |
|---|---|
| Answer | <p>In order to mitigate vibration and noise coming from running trucks over the joints, additional concrete was sprayed on the lower surface of the deck slab in the vicinity of joints (10m-long) with an aim to increase the stiffness of the slab in 2006.</p> <p>On September 2014, the additional spray-applied concrete fell off at the interface on the ground where the bridge operator manages.</p> <p>Dimension of the spray-applied concrete: length: 10m (L) * 5.25m (W) * 0.23m (T), about 30t (Weight)</p> <p>Inspection way and drain pipe were damaged when the concrete fell.</p> |

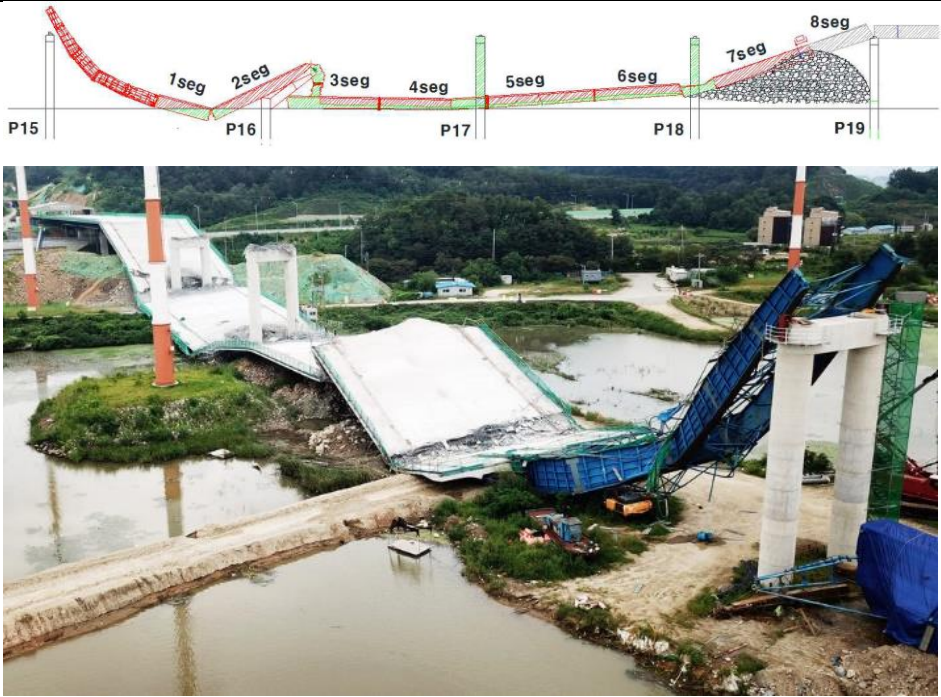
| Case : Incremental Launching Failure | |
|---|---|
| Answer | <p>The portion of the bridge constructed using the incremental launching method was divided into 36 segments for the launching operation. The typical length of the segment was 30 meters. During the launching of a 14th segment (405M), the launched portion of the girder was suddenly collapsed. A Pier 16 was also collapsed.</p> <p>Fortunately, no one was injured or killed. At the time of the collapse, the launching operation was stopped to replace the damaged sliding pad.</p> |

| Case : Incremental Launching Failure | |
|---|---|
| Answer | The Investigation Report from the AIC suggested that design and construction errors contributed the sudden failure of the bridge during the launching operations. The Report suggested that the shear strength requirements of concrete box girder was not fully considered for the ILM launching operation. It was also suggested that construction problems such as quality of grouting, cracks at construction joints, couplers for pre-stressing strands and poor shear reinforcement details contributed the failure. |

| Case : Incremental Launching Failure | |
|---|---|
| Answer | To reduce construction time, the failed pre-stressed concrete box girder was totally removed and replaced with a steel box girder. The steel box girder was assembled at the shop and transported to the site. |

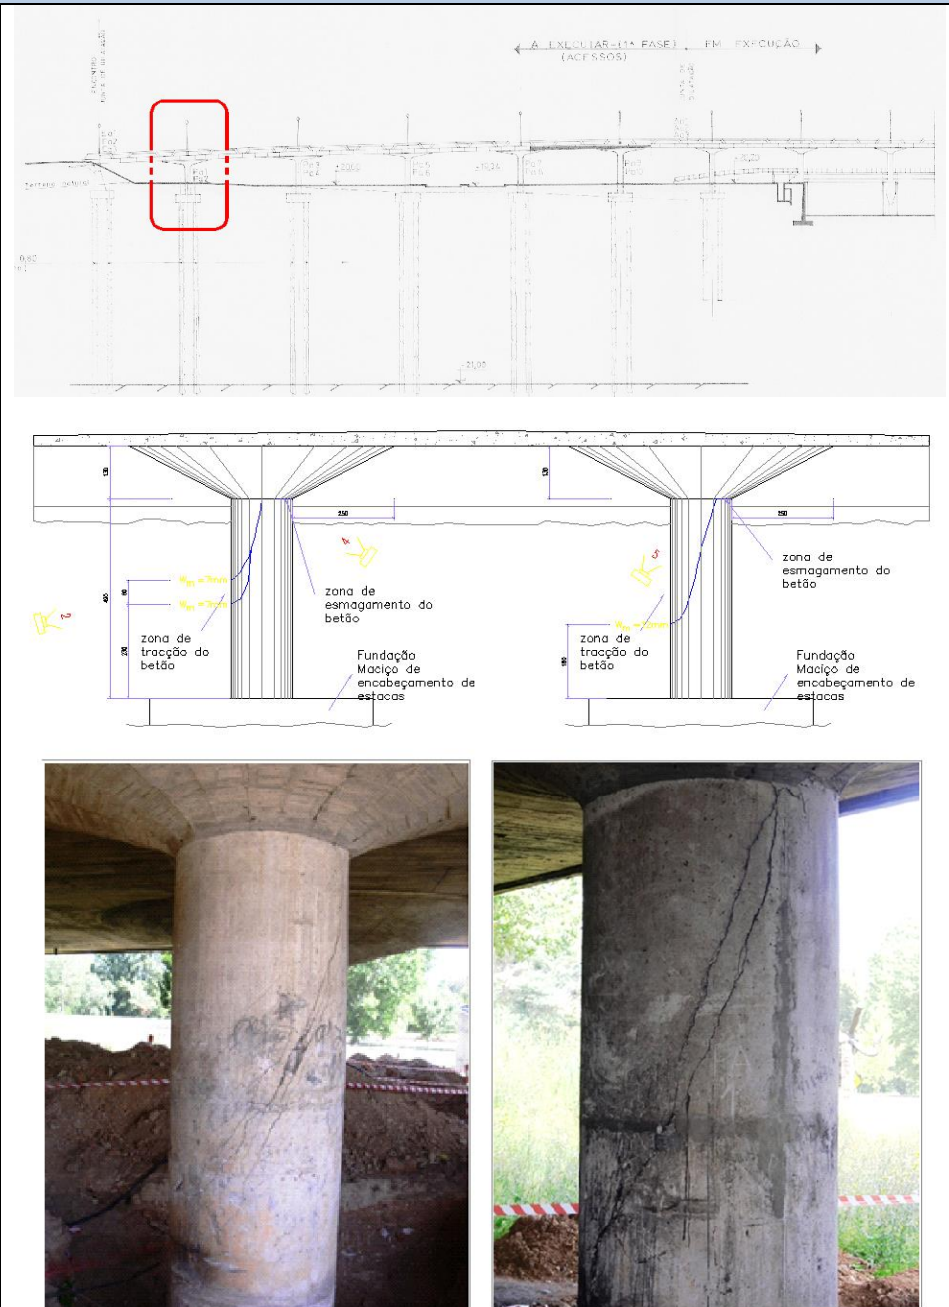
Picture of the failure

| <b>Case : Bridge Column Shear Failure</b> | |
|---|---|
| Answer | <p>Shear failure in 2 piers of the access viaduct (built in 1980). Shear capacity and ductility inadequate for the deformations/displacements imposed by the slab, due to long-term effects of concrete (shrinkage and creep) and temperature variation.</p> <p>It was a situation that suddenly appears.</p> |

| Case : Bridge Column Shear Failure | |
|---|---|
| Answer | Insufficient shear capacity due to inadequate transverse reinforcement (less than the minimum required according to the national design regulation and the Eurocode 2). |

| Case : Bridge Column Shear Failure | |
|---|---|
| Answer | Yes, there was a need for a timely repair.<br><br>That need had no impacted on the decision or process used by the investigation, because there was an urgent first repair / reinforcement of the 2 piers (even without a completed investigation on the structural behavior of the bridge). |

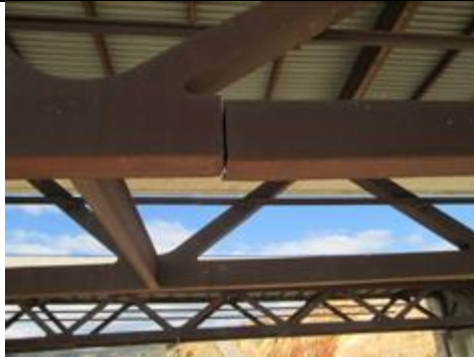
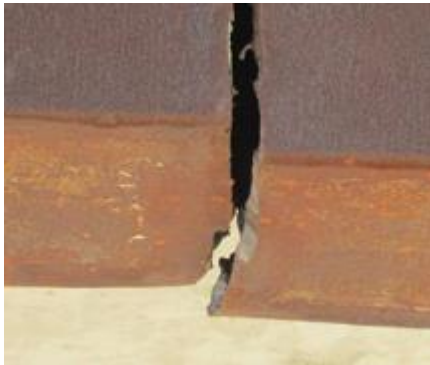
| Case : Hoces del Cabriel Viaduct | |
|---|---|
| Answer | <p>In 2013 a crack on the bottom chord was discovered just in the weld between the connection and the chord. A further inspection revealed that the crack may not have occurred recently but during time because of the presence of some rust on parts of the crack. However, the final crack may have appeared recently due to the lack of rust in that area.</p> <p>The crack initiation, propagation, and final fracture of the tensioned chord modified the structural behaviour of the truss, that unable to resist the bending moment through its decomposition into tension and compression forces, resulted in the plastic articulation of the connection immediately above the two affected diagonals, creating an anticlockwise rotation of the right lateral part (supported on the abutment and the plastic articulation) and a clockwise rotation of the left lateral part, clamped on the adjacent pile. This explanation matches the geometry of the observed crack, with a 3-4 cm aperture and a vertical displacement of 2-3 cm measured from the broken chord and the adjacent one.</p> |

| Case : Hoces del Cabriel Viaduct | |
|---|---|
| Picture of the failure | <p>General view of the crack</p> <p>Detailed view of the crack</p> |

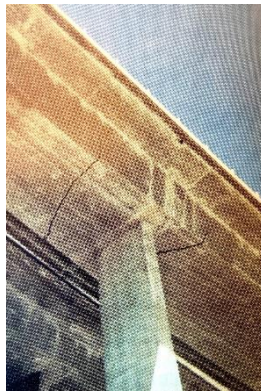
*Picture 2: Girder Box cracked over Pillar J*

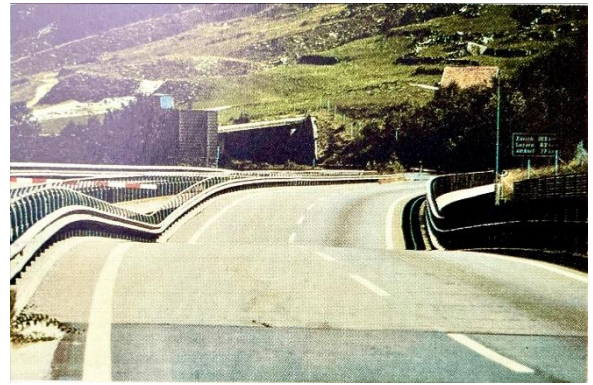
*Picture 3: Superstructure lowered by 1.2 m and rotated counterclockwise*

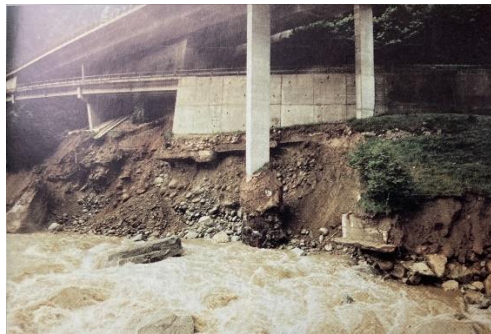
*Picture 4: washed-out foundation Pillar J; In the foreground a washed-out framework foundation that remained there. In the background the washed-out foundation of the sustaining wall carrying the cantonal route.*

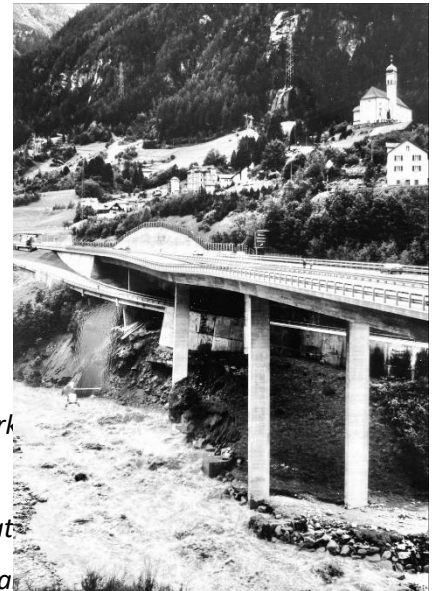
*Picture 5: The Reuss bridge Wassen, wounded*
