# FORENSIC ENGINEERING FOR STRUCTURAL FAILURES

A PIARC TECHNICAL REPORT

TECHNICAL COMMITTEE 4.2 *BRIDGES*

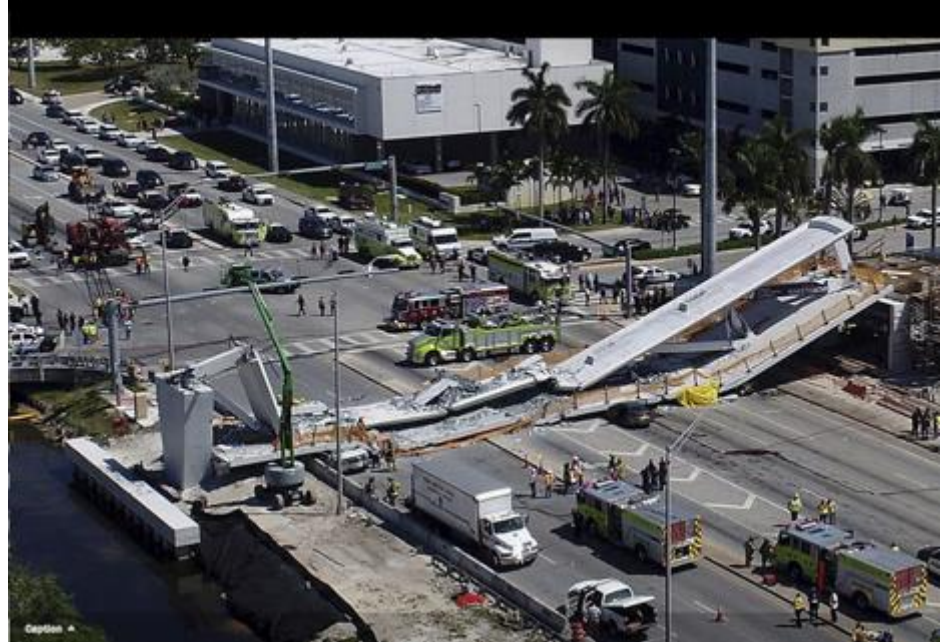
Picture of the failure

| Case : Florida International University Pedestrian Bridge | |
|---|---|
| Answer | The FIU Pedestrian Bridge experienced a catastrophic structural failure within the node connecting truss members 11 (diagonal) and 12 (vertical) and the bridge deck at the north end of the main span. As a result, the bridge span fell about 5.5m onto SW 8th Street, which consists of four through travel lanes and one left-turn lane in the eastbound direction, and three through travel lanes in the westbound direction. Two of the westbound lanes below the north end of the bridge were closed to traffic at the time of the collapse; however, one westbound lane and all five eastbound lanes were open. At the time of the collapse, a construction crew was working on retensioning the post-tensioning rods within the diagonal truss member 11, connecting the bridge canopy and the deck at the north end. Eight vehicles located below the bridge were fully or partially crushed. One bridge worker and five vehicle occupants died. Five bridge workers and five other people were injured. |

This photograph shows the main span shortly after collapse:
